Technical report

A-021/2022

Accident on 09 April 2022 involving a Diamond DA-40 aircraft with registration EC-IQD, operated by Aerotec Escuela de Pilotos, at Cuatro Vientos Airport (Madrid)

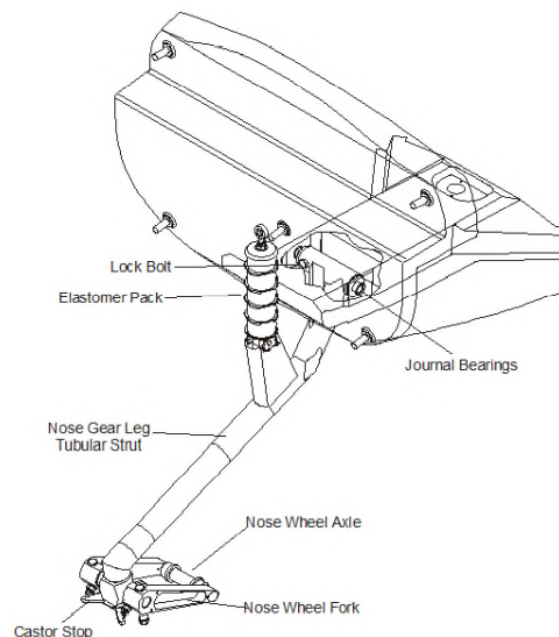
The strut has a welded bracket that holds an elastomer pack, the upper end of which is attached to the engine mount.

At the lower end of the strut is a near-vertical pivot for the fork, which allows the wheel to move. The stoppers limit this rotation to within $\pm 30^\circ$. A lateral load on the wheel rotates it on the axle. The fork pivot's rigidity (steering friction) can be adjusted with its lower mounting screw.

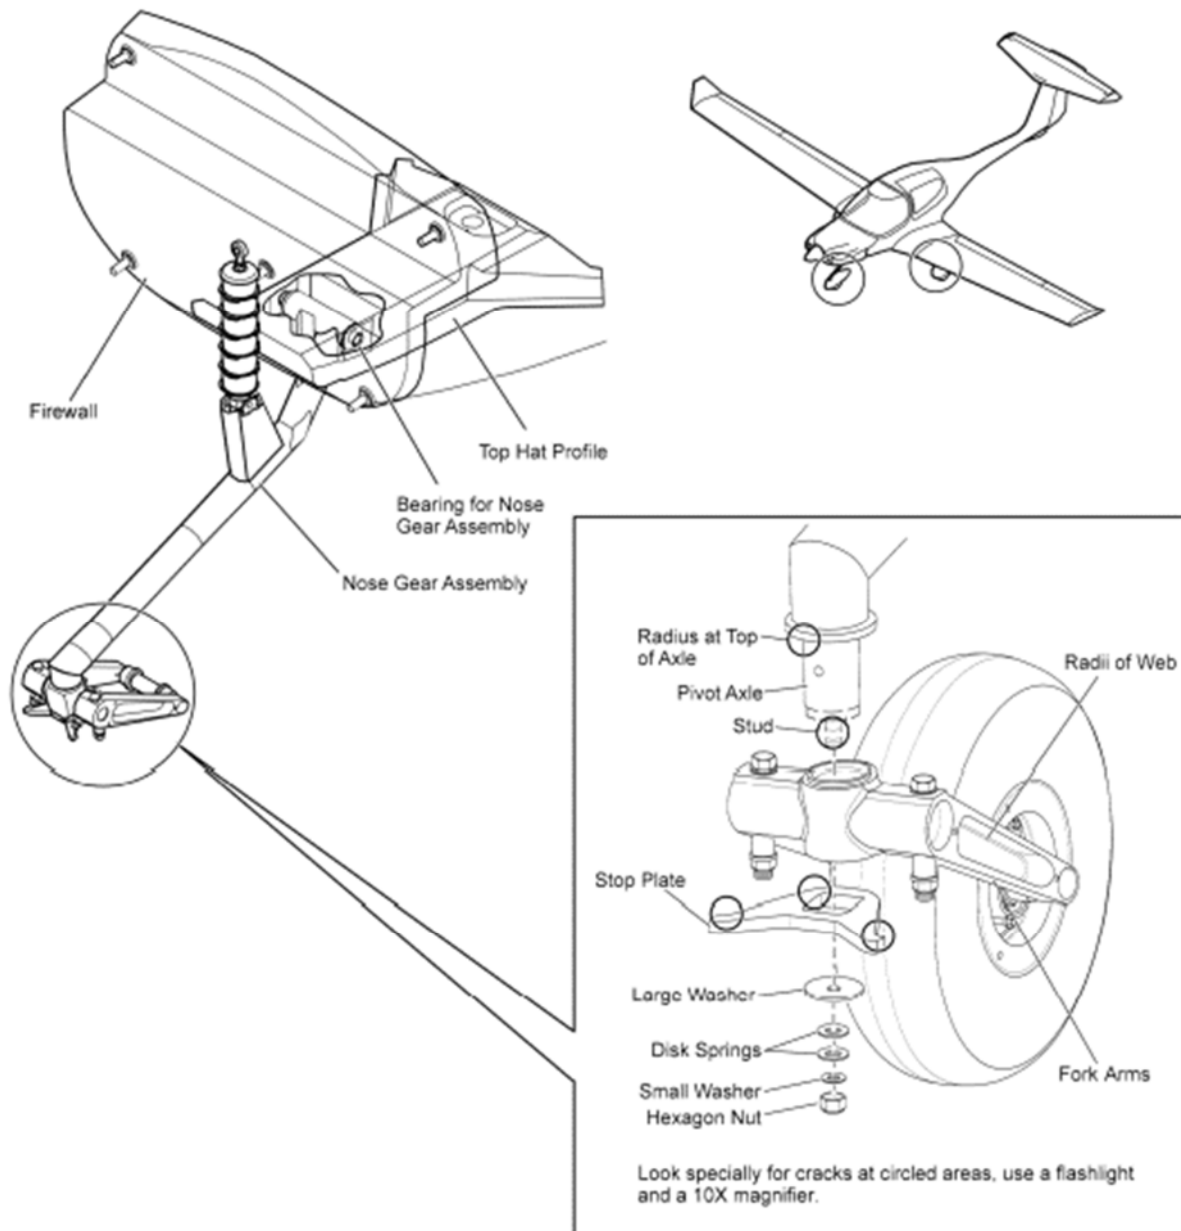
The next figure shows a description of the nose leg components together with an enlarged diagram of its fork:

Subsequently, in 2008, Diamond issued mandatory service bulletin MSB 40-046, which specified that the pivot axle on the nose gear fork (see the area marked by the arrow in the figure on the right) should be inspected for fatigue cracks:

Diamond stated in this service bulletin that if a crack is found, the leg should be replaced. If the installed leg was P/N D41-3223-10-00_1 or higher, no further action was required by Diamond.

Diamond states that the terminating action for the service bulletin is to replace the nose leg with the redesigned part number D41-3223-10-00_2 or higher.
