# Technical report

## A–029/2022

### Accident on 04 June 2022 involving a TECNAM P2008 JC aircraft, registration EC- NKE, at Madrid-Cuatro Vientos Airport (Madrid, Spain)

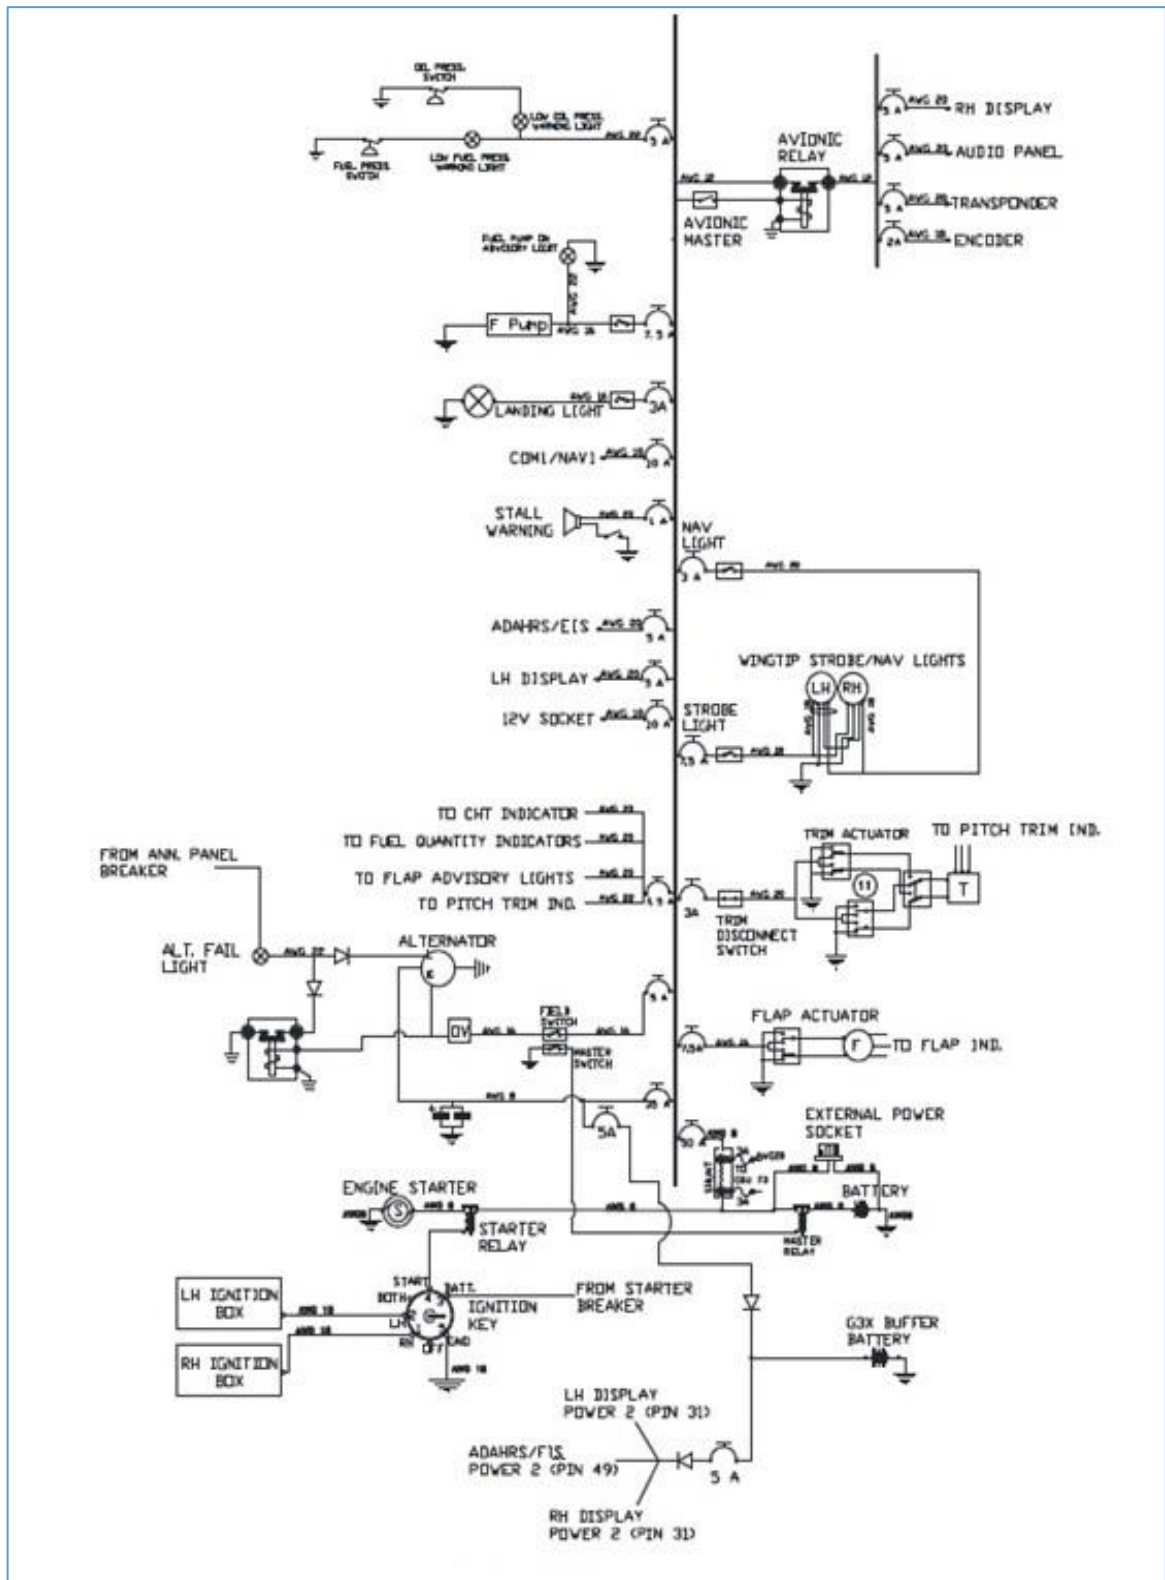
**Figure 2. Electrical system of the TECNAM P2008JC**

The image in Figure 2 includes the electrical diagram of the aircraft provided in the maintenance manual. The primary source of electrical energy is a belt-driven alternator, shown in the diagram, to power the electrical loads.

The mixture is ignited in the cylinders by two electronic ignition boxes, which are powered by the alternator once the engine is running.

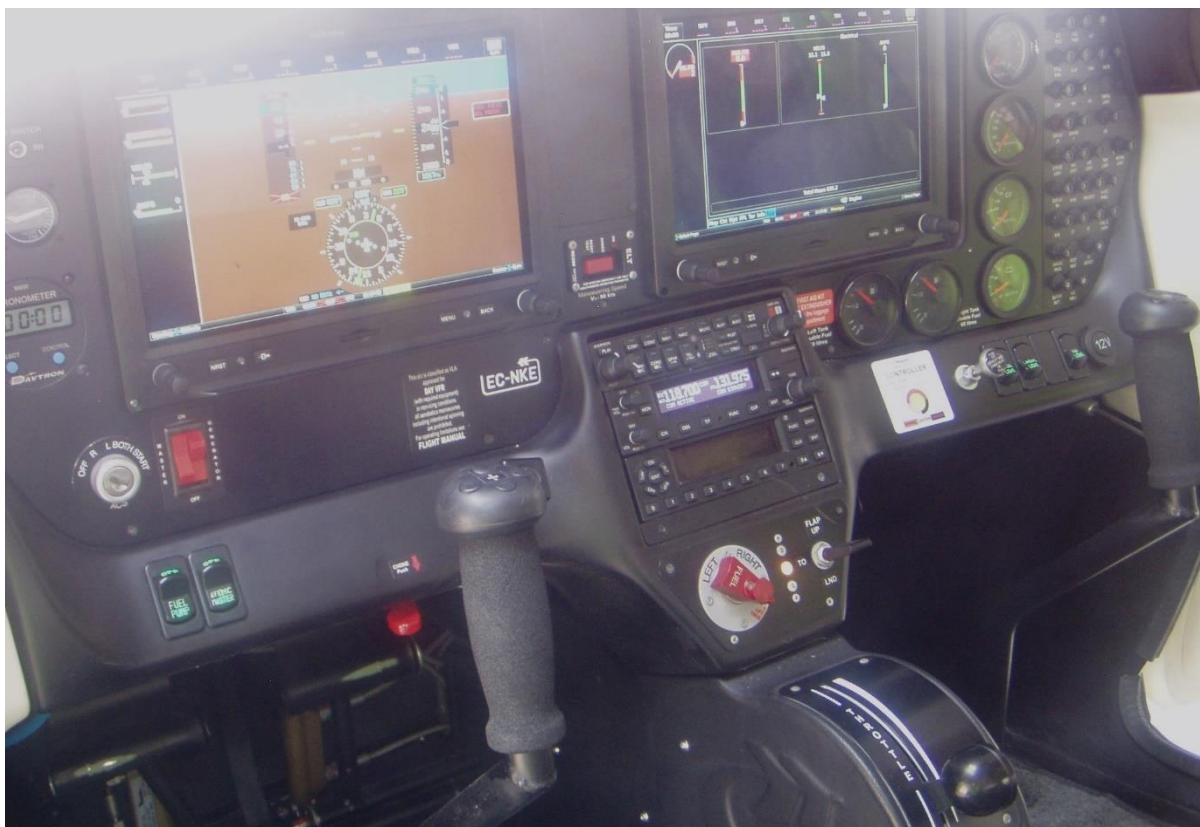
**Figure 3. Control panel on the TECNAM P2008JC**

Figure 3 shows an image of the aircraft's instrument panel extracted from the Flight Manual. It can be appreciated the unavailability of basic analog flight instruments (airspeed indicator, altimeter and variometer).

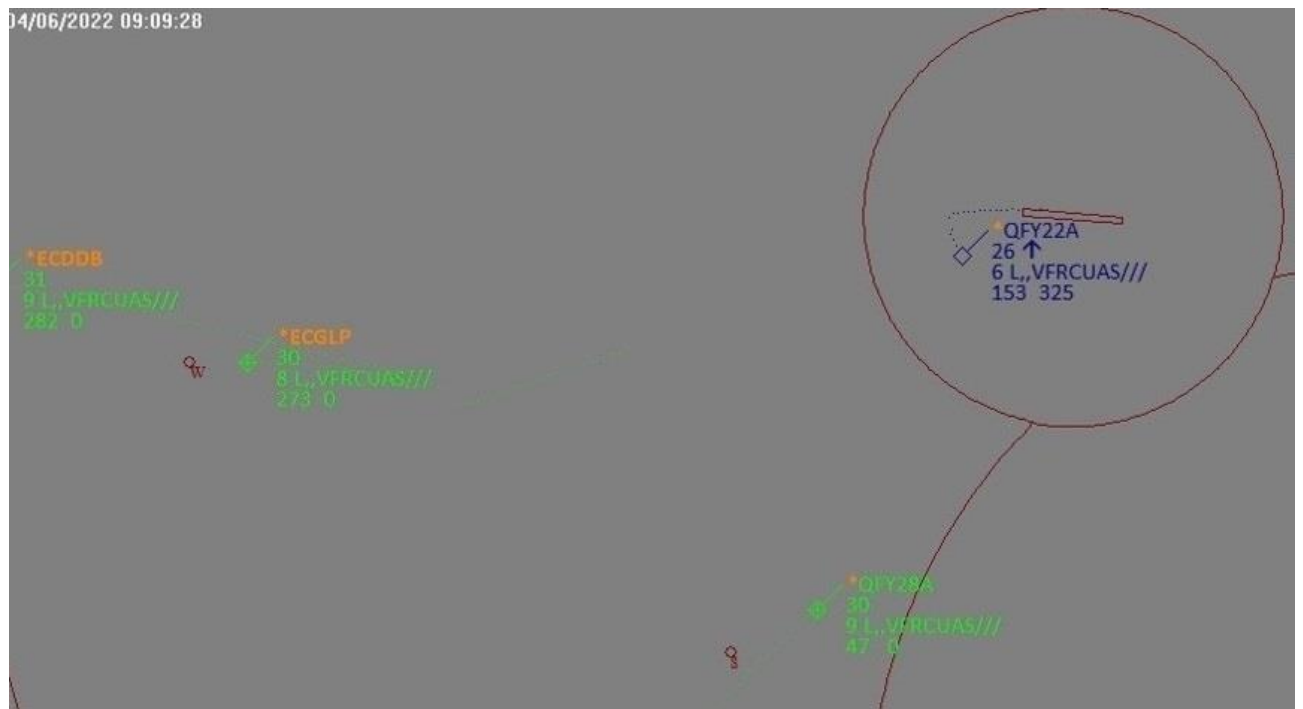
Figure 4. Radar trace at 11:09:28 h

The images in Figures 4 and 5 include the radar trace of the aircraft, with call sign QFY22A. It can be seen that at 11:09:29 HL it disappears from the screen.
