# Technical report

## **A-031/2021**

Accident on 11 July 2021 involving a Bell412 helicopter operated by Rotorsun, registration EC-MTS, in Ejea los Caballeros (Zaragoza-Spain)

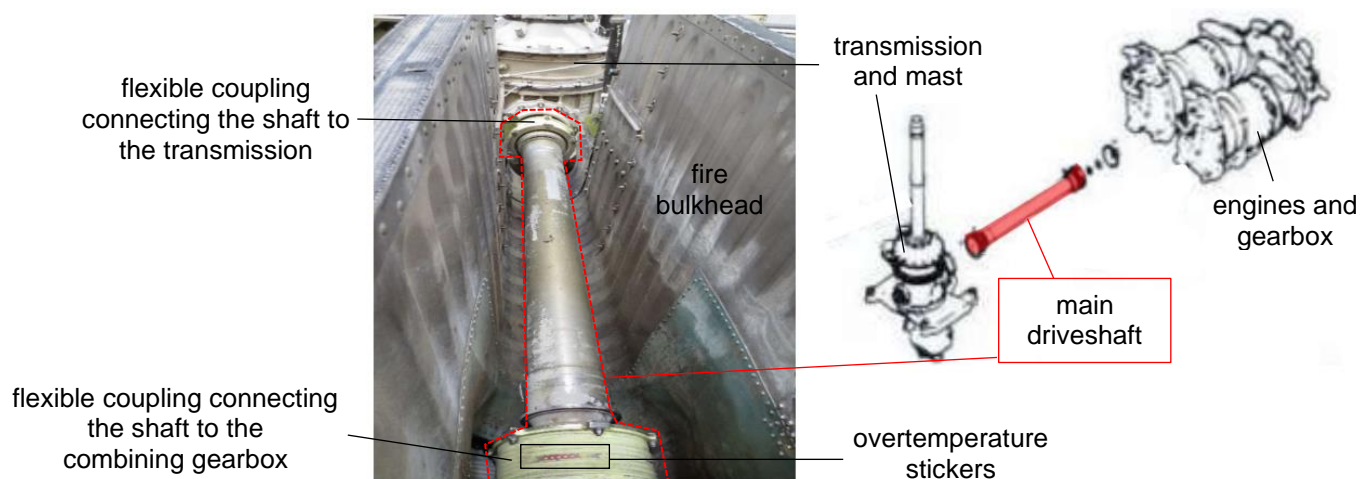
Figure 2. Main driveshaft

The main driveshaft is, therefore, connected at one end to the gearbox (via an adapter) and at the other end to the transmission. To absorb vibrations and allow a certain amount of play between these elements (gearbox-shaft-transmission), the ends of the driveshaft have greenish flexible couplings (figures 2 and 3), which are connected with 6 threaded joints consisting of a bolt-washer-self-locking nut system on each flange. In total, each coupling requires 12 joints, and the complete shaft requires 24. In these threaded joints, between the washer and the part, the counterweights that might be needed to balance the shaft are installed. In this case, the assembly would then look like this: bolt-washer-counterweight-part-nut. This balancing must be carried out each time the shaft is uninstalled (according to Maintenance Manual BHT-412-MM). There are also stickers that detect overtemperature in the coupling by changing the colour of their circles (from white to black).

In the EC-MTS helicopter accident, the flexible coupling connecting the main driveshaft to the gearbox was found to be disconnected, and the 6 threaded joints on that flange had separated.

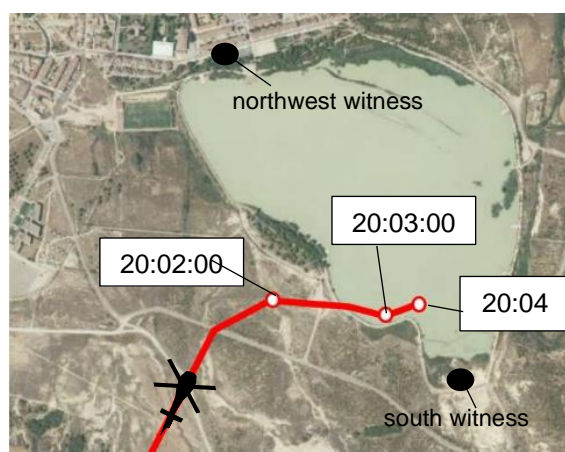
Figure 4. Last two minutes of flight (20:02-20:04)

- 20:02 Start of the approach to the reservoir on an easterly course. The helicopter was at 139 ft altitude, 32 kt GS and 250 m from where it would begin the operational tests of the helibucket.
- 20:03 The helicopter was hovering over the reservoir. This is assumed to be the point at which the tests, and therefore the event, began. The altitude and speed data recorded at this stage are not considered reliable, so the calculations obtained from the videos have been used.
- 20:04 Impact with the water.

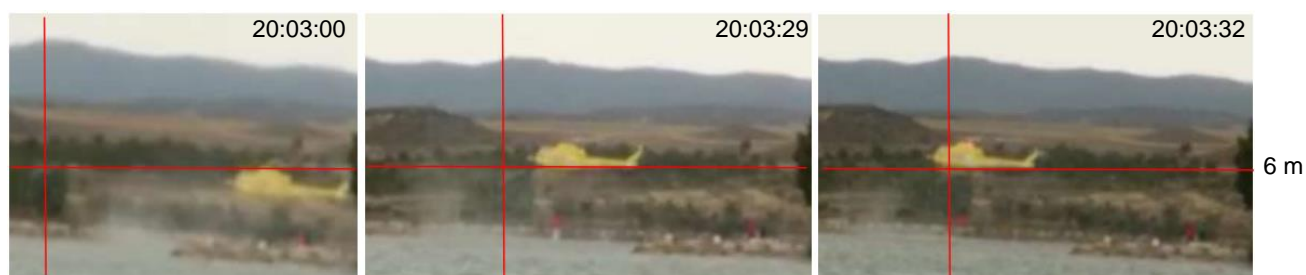
Figure 5. Last minute: first ascent-descent cycle (20:03:00 to 20:03:35)

Figure 5 shows the first cycle of ascent and descent, recorded only by the witness positioned to the northwest. Figure 6 shows the second ascent-descent cycle from the two perspectives of the two witnesses.

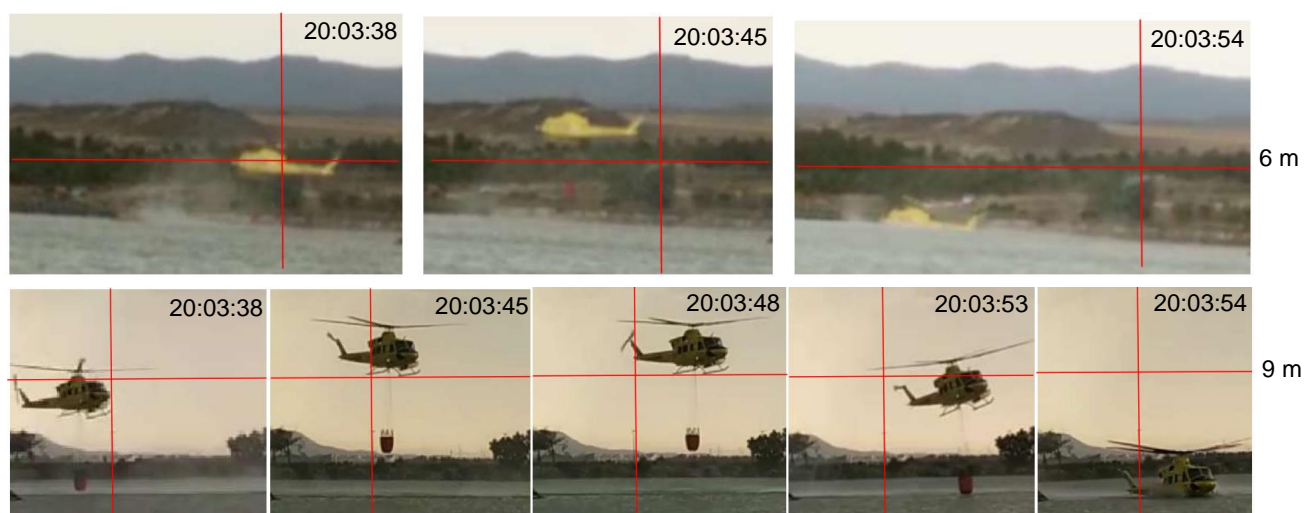
Figure 6. Last minute: second ascent-descent cycle (20:03:38-20:03:54)

In this second ascent-descent cycle, the horizontal displacement was 30 m with a GS of 3.6 kt. The descent rate between 20:23:48 and 20:03:52 was 123 fpm. From 20:03:52 to 20:03:54, it was 690 fpm.
