Report A-037/2018

Accident involving a Piper PA-28R-200,
registration EC-HSZ, at the Cuatro
Vientos Airport (Madrid)
on 4 September 2018.

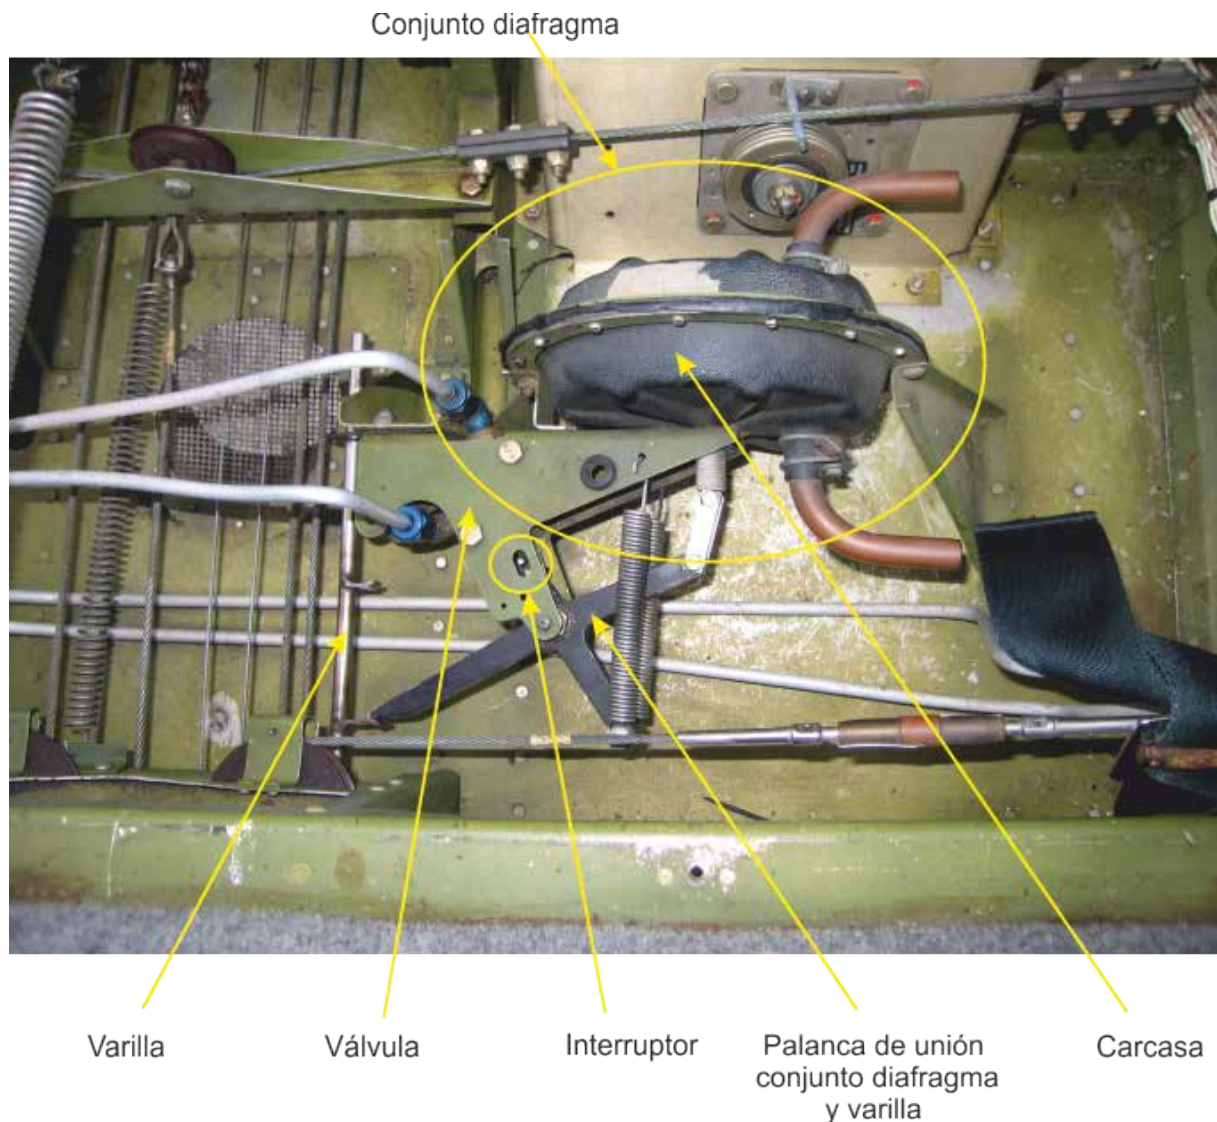
Fig. 3.- Automatic gear extension system

As described in the Pilot's Operating Handbook, this system is controlled by differential air pressure across a diaphragm that is mechanically joined to an electric valve and a switch that turns the electric-hydraulic pump on. The system that provides static and ram air pressure to this diaphragm is located on the left part of the fuselage, above the wing. Any blockage of the orifices could cause the gear to lower.

The main cause for this system's failure to operate properly is the poor condition of the diaphragm. As a result, there is a Service Letter (No. 810) in which the manufacturer provides guidelines for replacing it when necessary.

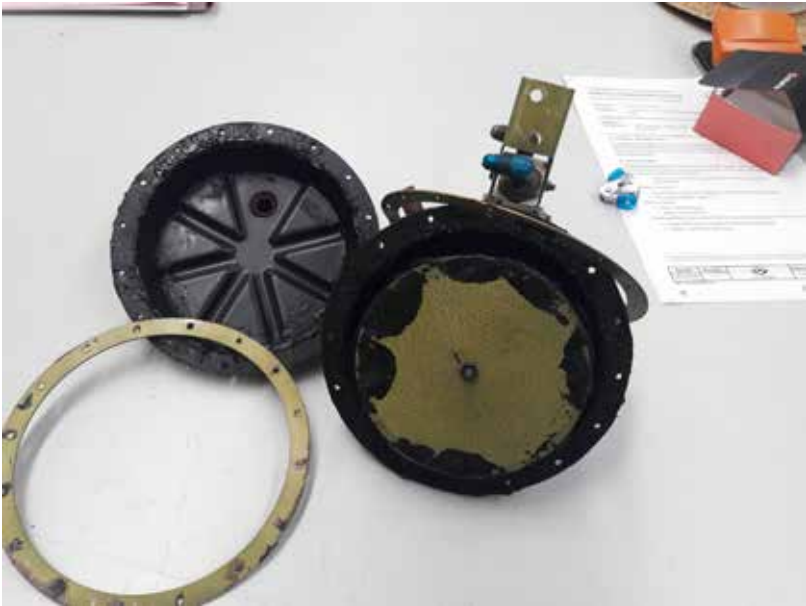
Fig. 9.- Pressure sensing assembly

As for the pressure sensor mechanism, once opened it was found to be blocked because the diaphragm assembly, consisting of a membrane and circular metal supports, was stuck to one of the sides of the casing that housed it, which prevented it from moving.

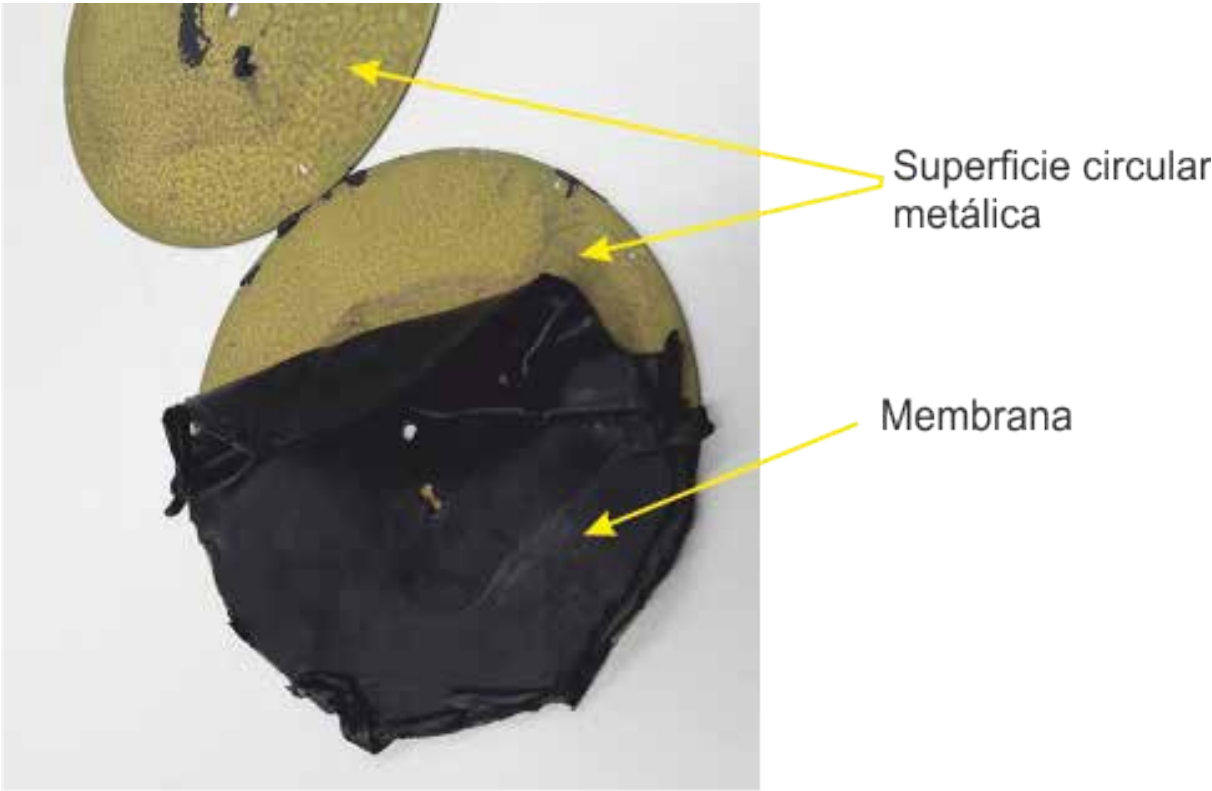
Fig. 12.- Internal view of diaphragm assembly

Opening the casing that contained the diaphragm revealed that the membrane had deteriorated and stuck to one side of the casing (see Fig. 8), precisely in the position where it would be when the lever is in the topmost, or override, position, which disarms the automatic gear extension system. As a result, the rod was only able to move as far as the distance between its two tabs – which push the diaphragm – a distance that, as the diagram/photo show, is insufficient to change the condition of the landing gear mechanism (see Fig. 3).
