# Report A-047/2019

Accident involving a Cirrus SR22 aircraft,  
registration F-HAMP, in the municipality of  
Pedreguer (Alicante) on 15 September 2019

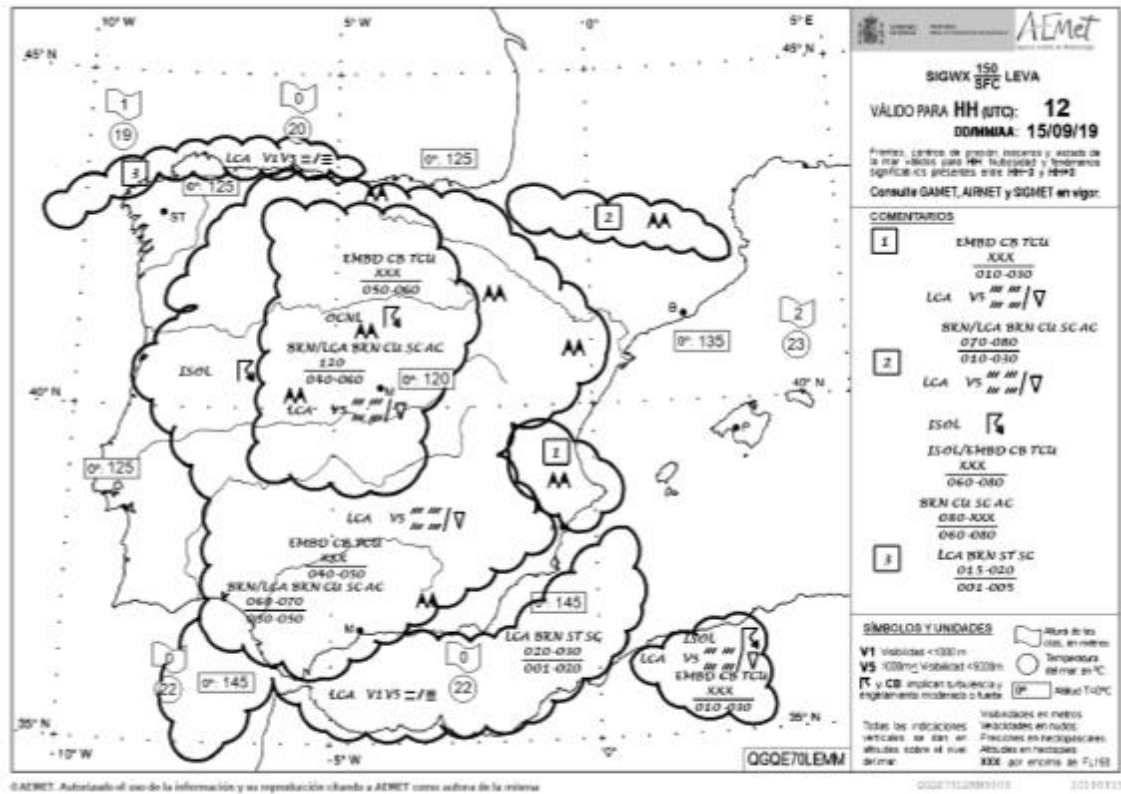
Illustration 1 Significant low-level chart for 12:00 UTC

Remote sensing images do not show convective activity in the area of the accident or in the destination or departure aerodromes. It is highly likely, however, that there were low, stratiform clouds, which resulted in fog in mountainous areas. The mountain obscuration symbol shown in the low-level forecast for 12 UTC and 18 UTC warned of this possibility in the area of the accident, and that the visibility could fall to 5 km.

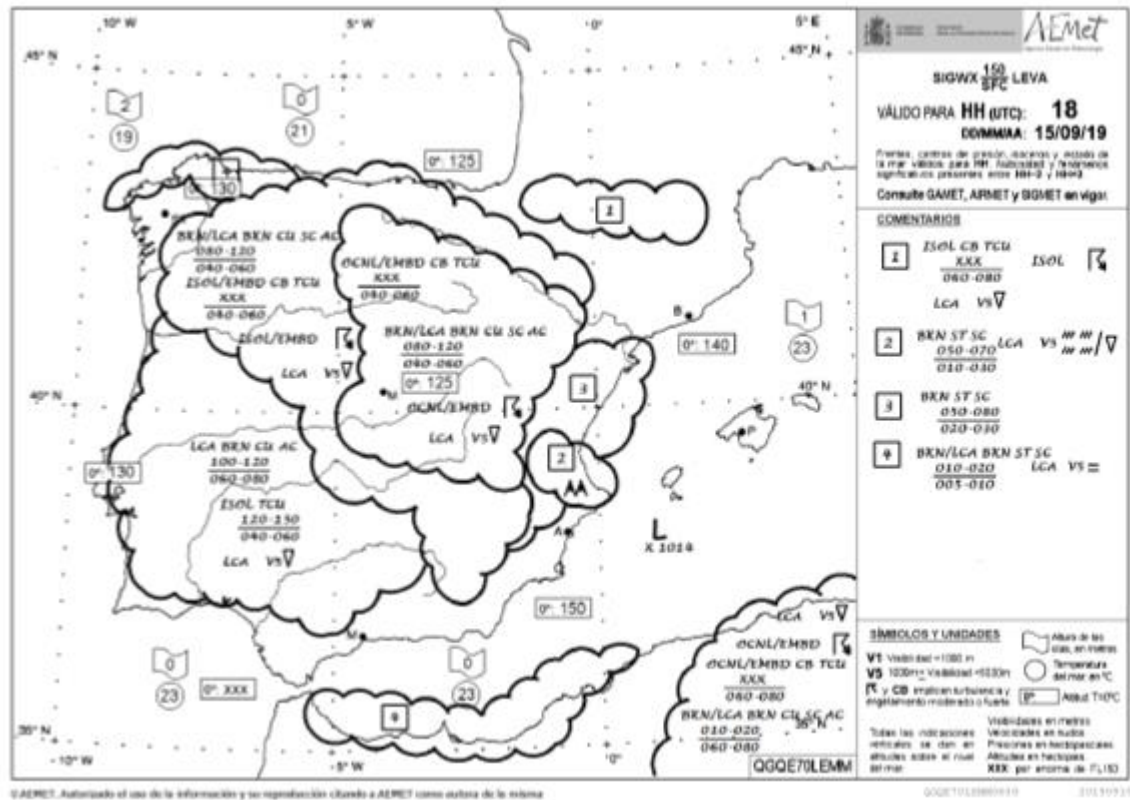
Illustration 2: Significant low-level chart for 18:00 UTC

In conclusion, according to AEMET, the situation was favorable to persistent low clouds in mountain summits and significantly reduced visibility caused by stratiform clouds touching the ground at high elevations, which very likely contributed to the accident.

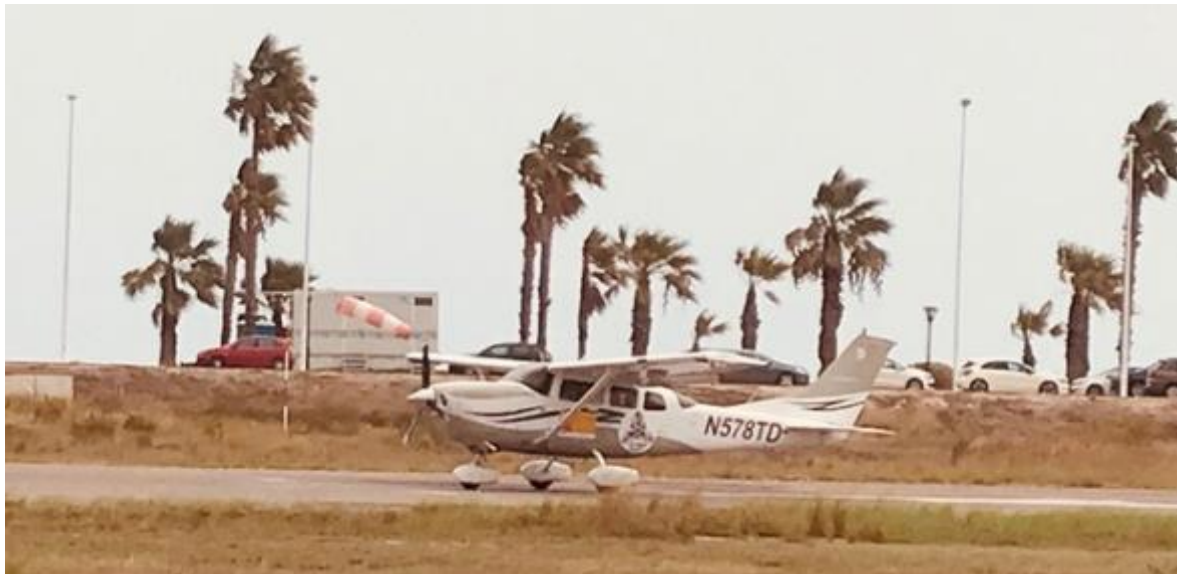
*Illustration 3: Wind at the Pinar de Castellon aerodrome as one of the aircraft takes off*

The photo below, taken by an aircraft taking part in the air rally, shows the takeoff of aircraft N-578TD, which took off after the accident aircraft, and the wind that was present at the time.

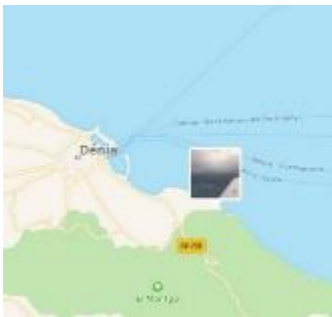
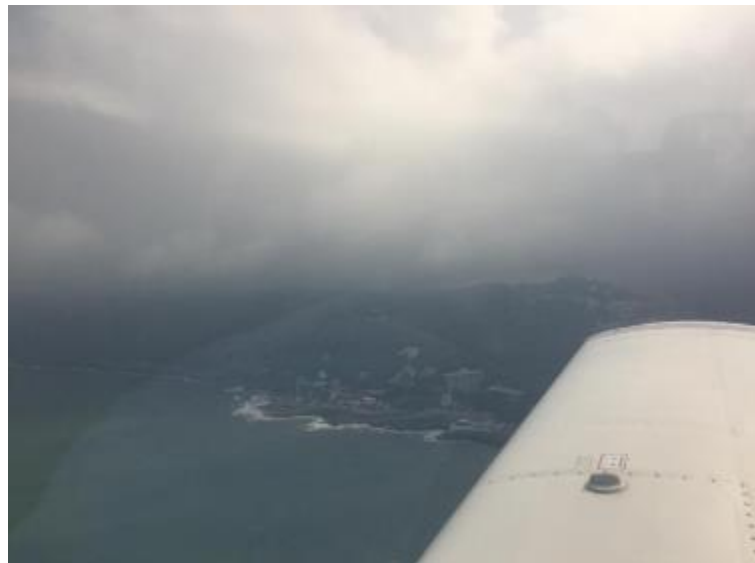
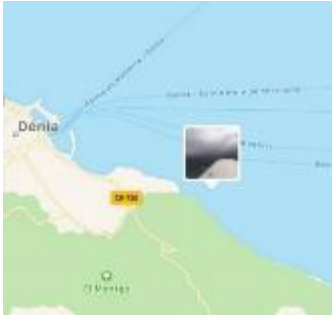
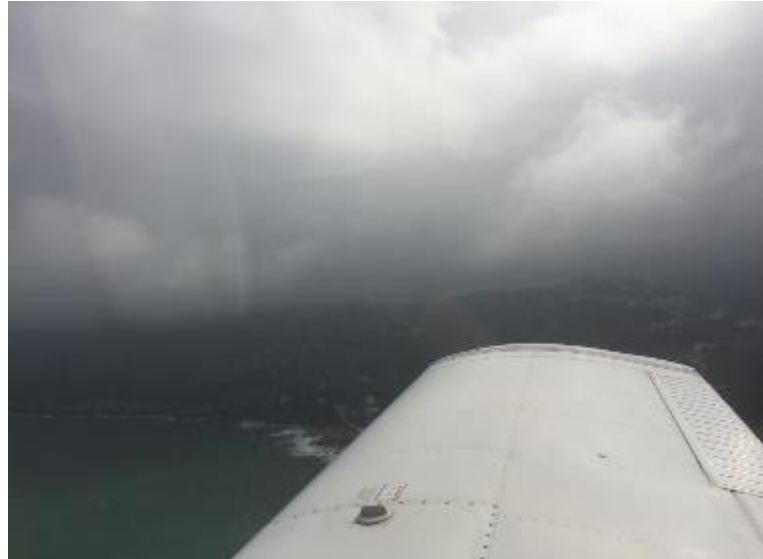
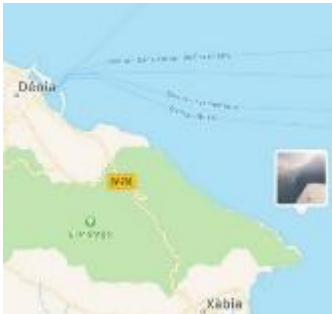
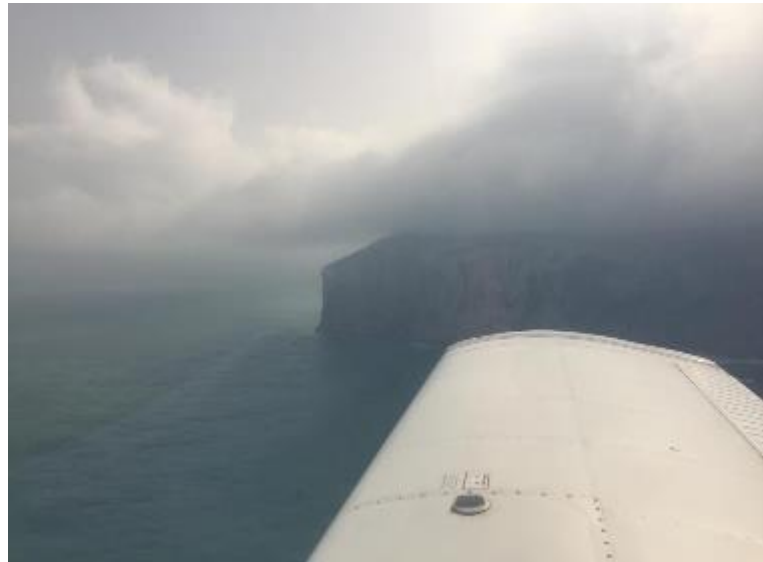
These other topographies were taken by a passenger onboard HB-OQN aircraft. This aircraft took off 27 minutes later than the accident aircraft. The left figure shows the aircraft position when the right photograph was taken:

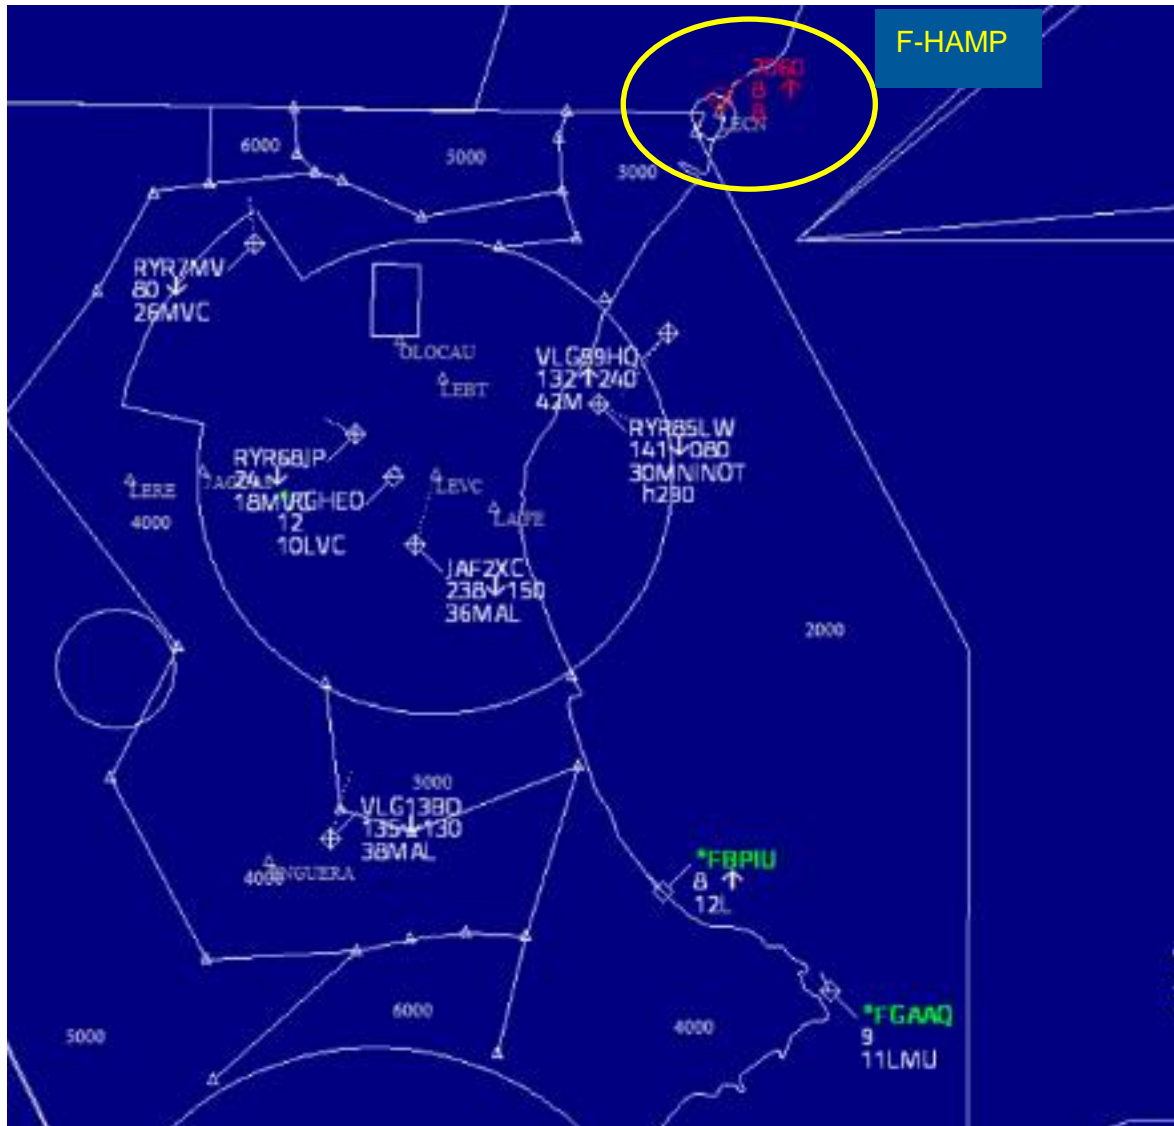
Illustration 5: Positions of F-HAMP, F-BPIU and F-GAAQ at 15:18

At 15:18 (13:18 UTC), the accident aircraft had just taken off from the aerodrome of Pinar de Castellon and was climbing. Aircraft F-GAAQ (which took off half an hour before the accident aircraft en route to Mutxamel) and F-BPIU (lead aircraft, which took off from the Requena aerodrome) were near Cape Nao.

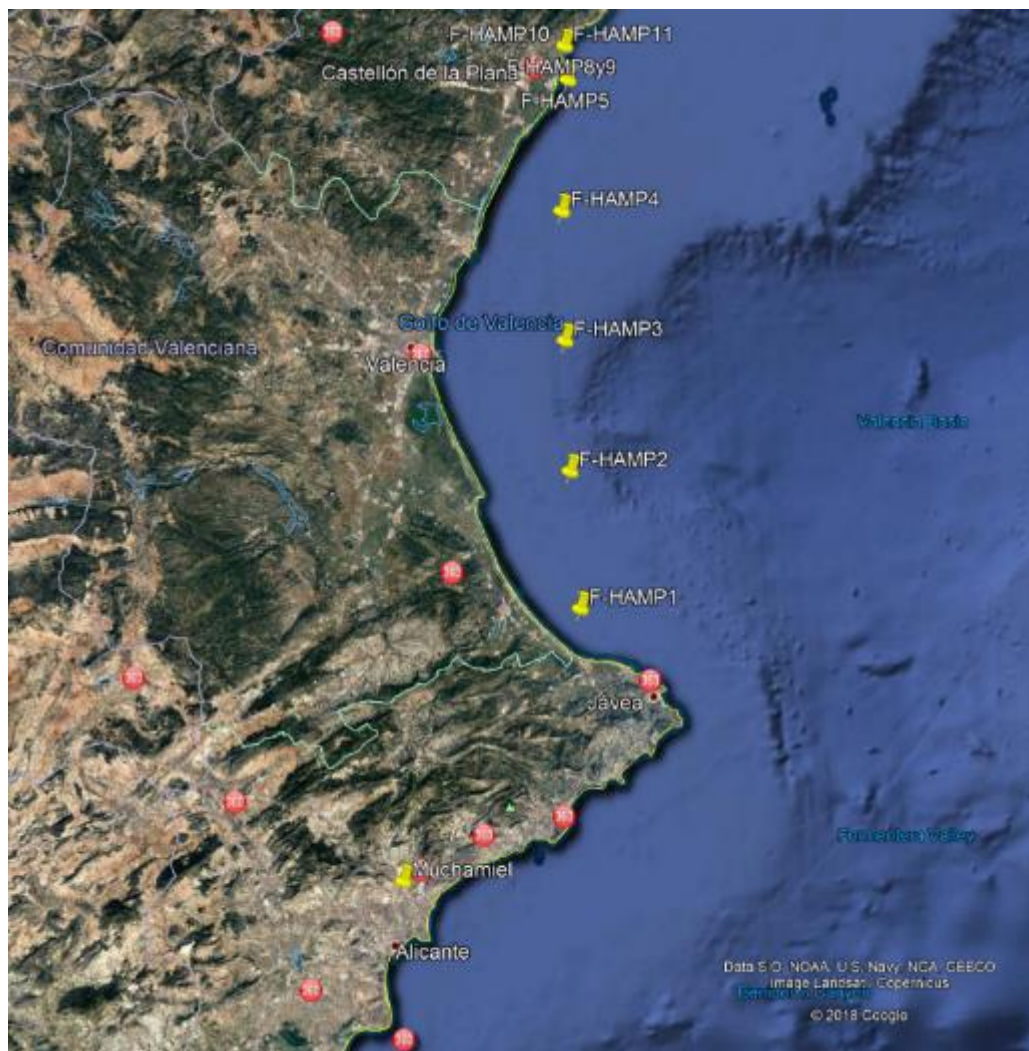
*Illustration 9: Aircraft's position at various time during the flight*

The positions transmitted until 15:41 are shown in the image below:

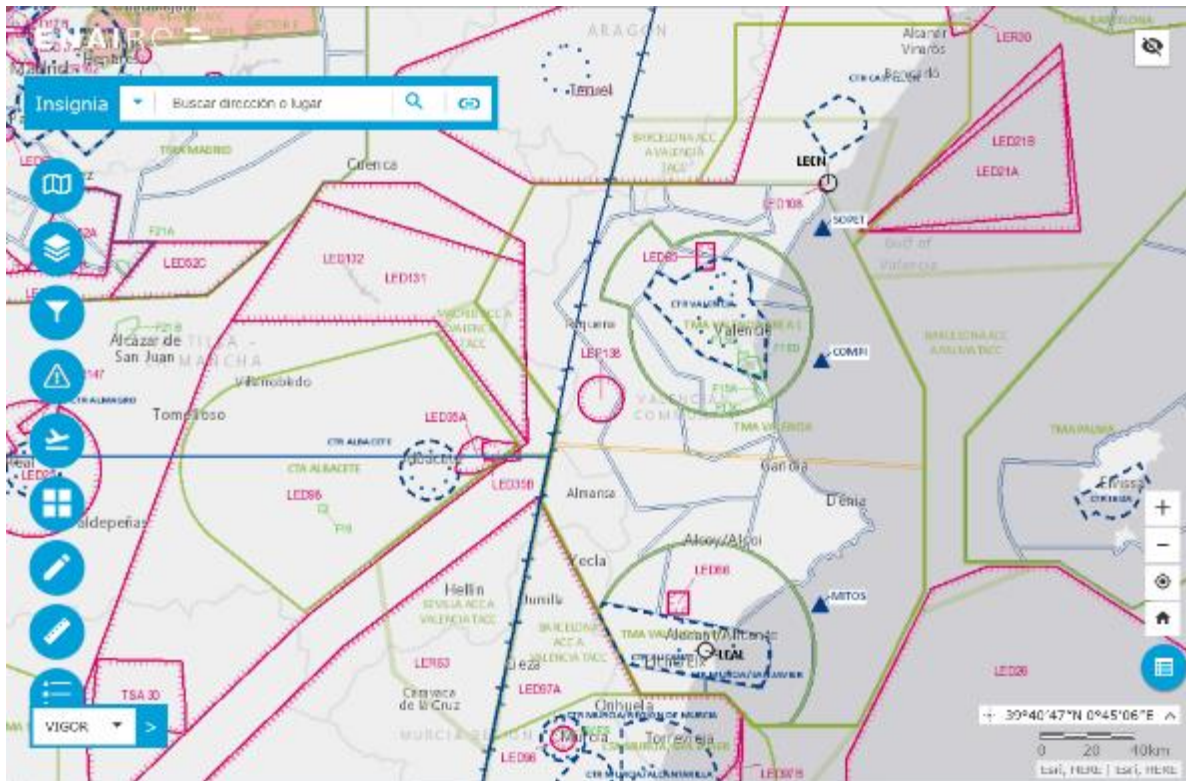
Illustration 12: Location of reporting points flown over by the accident aircraft

According to the final flight plan, the aircraft left from the aerodrome of Pinar de Castellon at 15:15 (13:15 UTC) and would fly over reporting points SOPET, COMPI and MITOS en route to the aerodrome of Mutxamel.

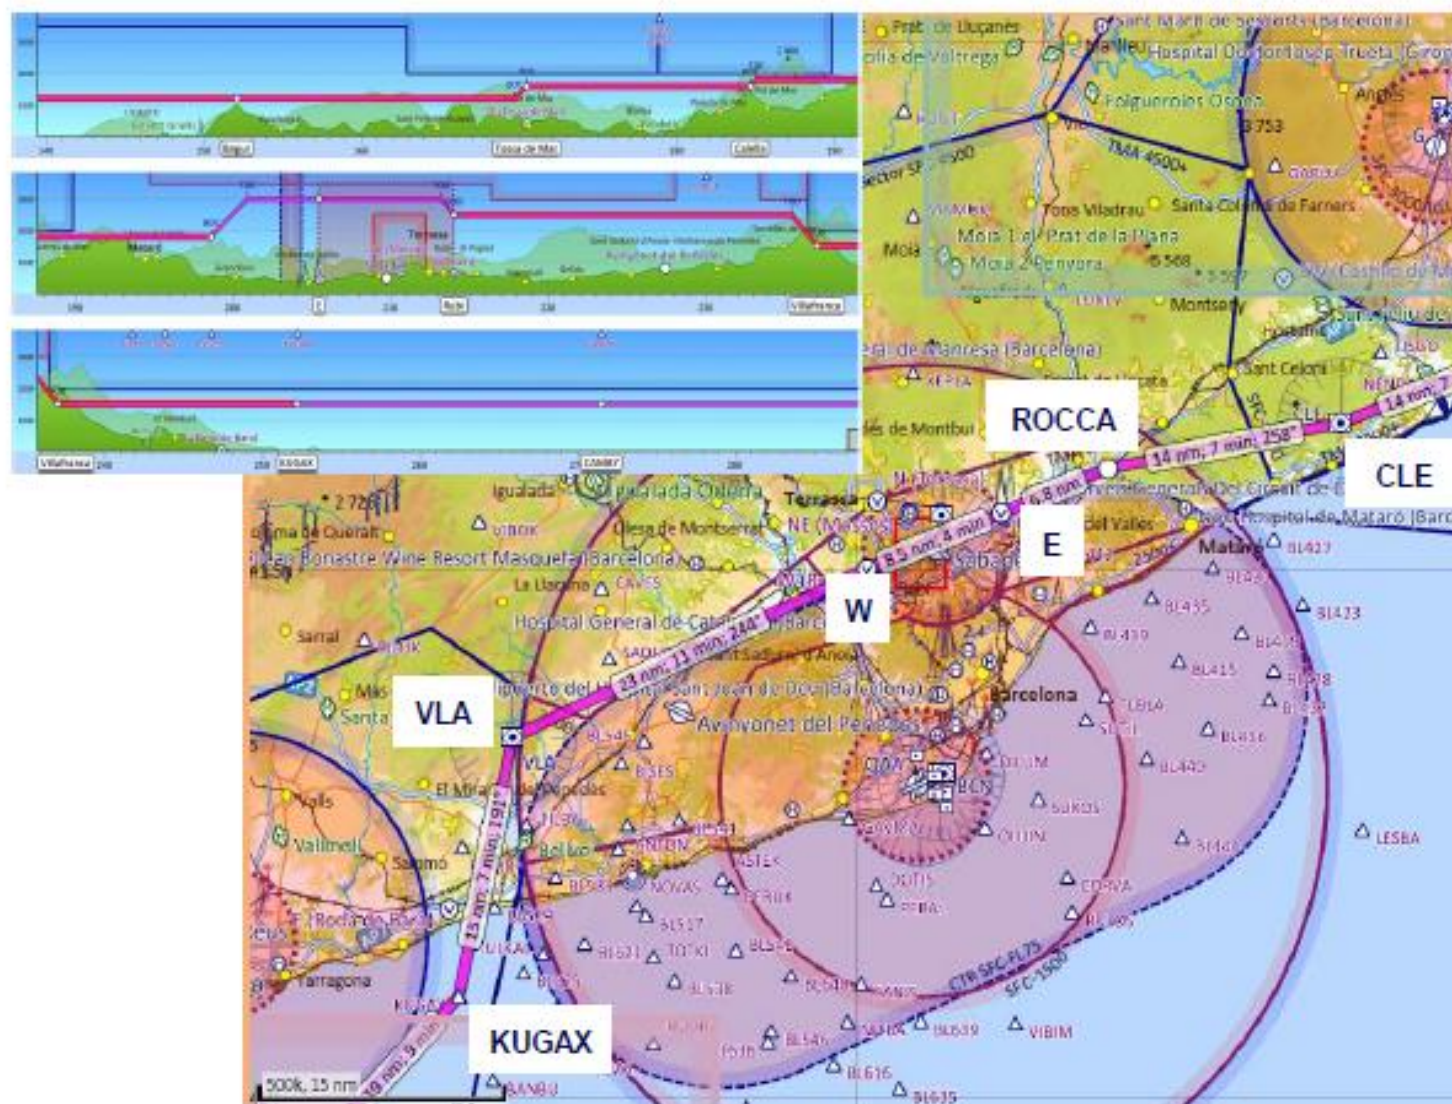
Illustration 13: Close-up of the route proposed for 14 September

On 14 September, the first stage of the air rally was held between the aerodromes of Perpignan and Pinar de Castellon. The planned route was to go through the ATZ of the Sabadell airport, entering it via reporting point E and exiting it via W at an altitude of 3000 ft. The documentation from the organizers specified that after crossing the border, crews were to tune into the Barcelona frequency (INFO 127.70 MHz) until reporting point VLA (Villafranca VOR).

At 12:37 UTC, several aircraft taking part in the air rally (specifically, N-578TD, F-HAMP, F-HAVG, F-PURU, F-GUVC and F-GNPJ) crossed the ATZ of the Sabadell airport (LELL)<sup>17</sup> from east to west at different altitudes (from 1700 to 3000 ft) without establishing radio contact with the controller in the control tower at said airport.
