Technical report

A-049/2021

Accident on 22 October 2021, involving a
Eurocopter AS-350-B3 aircraft,
registration EC-JEA, operated by Eliance, in the
Vall d'Arán, Lérida (Spain)

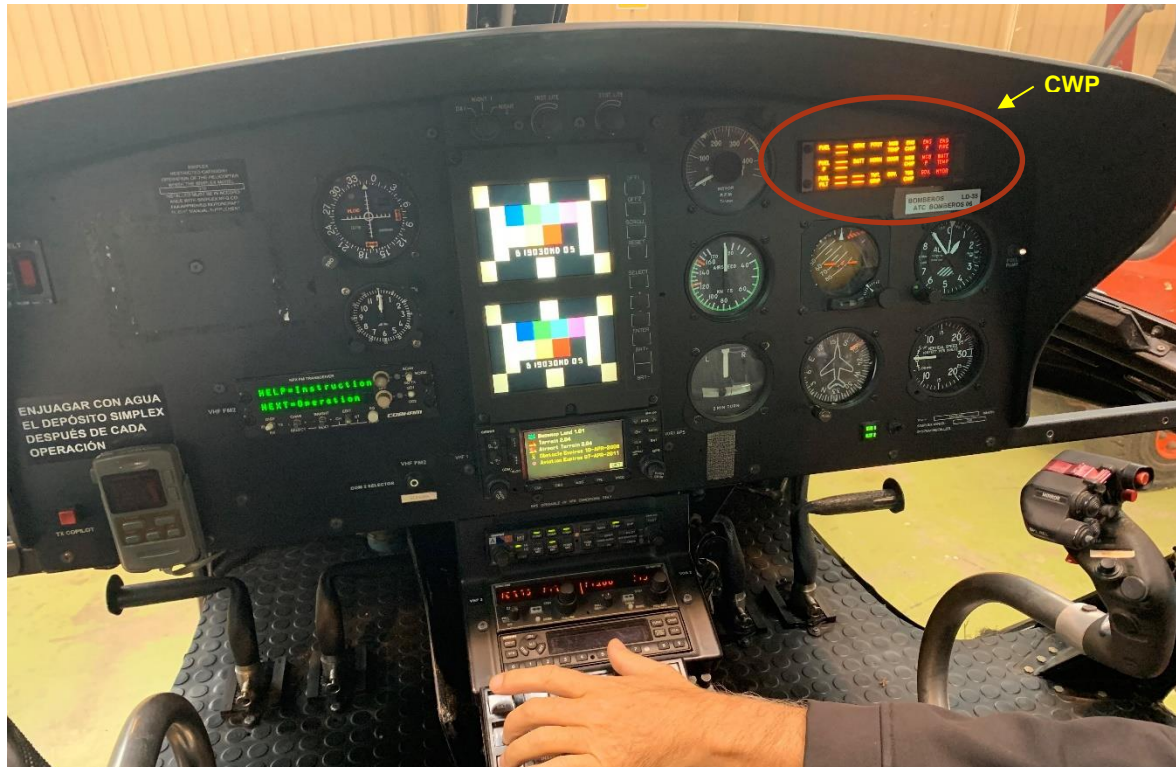
Photograph 2. Instrument panel in the model 2B incident aircraft

The following photographs show the panels of the AS-350-B3 2B aircraft involved in the event and that of the AS-350-B3 2B1 helicopter to highlight the differences between the two that may have influenced the pilots' operation of the aircraft during the event, given that the crew were training in the 2B model when they usually flew the 2B1 model. Photographs 4 and 5 highlight the fundamental differences between the CWP in the two models.

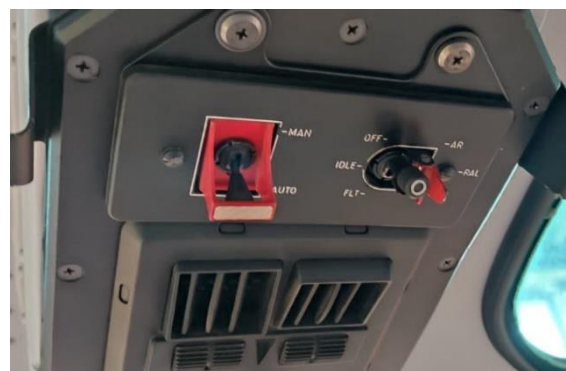
Photograph 6. Selector AUTO-MAN

The governor's mode of operation is determined by the selector located in the upper part of the cockpit, which has AUTO/MAN options to select automatic and manual modes, respectively. In automatic mode, the governor automatically regulates the engine's fuel flow; in manual mode, fuel flow adjustments are made by manually turning the twist grip.

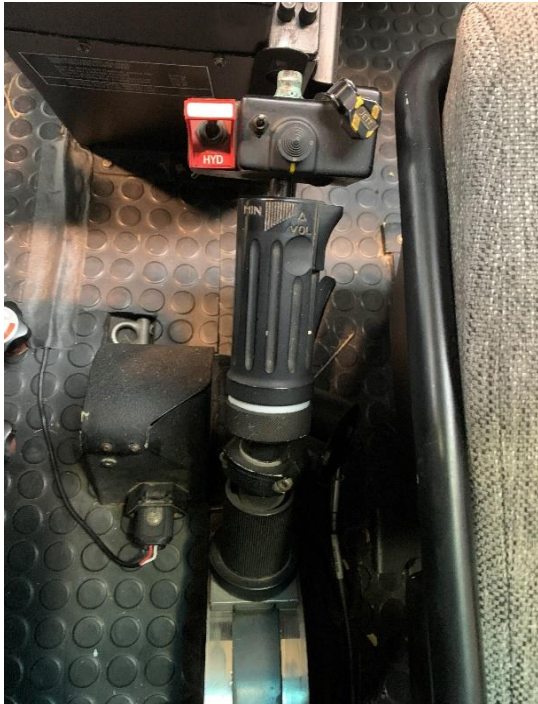
Photograph 8. Collective in the 2B accident model

The twist grips on the 2B and 2B1 models (photos 8 and 9) differ in the following ways:

- Model 2B: MIN and VOL positions or flight position can be selected on the twist grip. Older serial numbers (PRE MOD 073084) were equipped with a manual locking and unlocking device to set the emergency range taking the form of a red push-button, while those manufactured after 01/01/2003 (POST MOD 073084) have an automatic electrical release that activates when the red GOV light on the CWP comes on.
- Model 2B1: IDLE and FLIGHT positions can be selected on the twist grip or flight position, and it has a fully independent emergency backup system that automatically engages in the event of a governor failure.

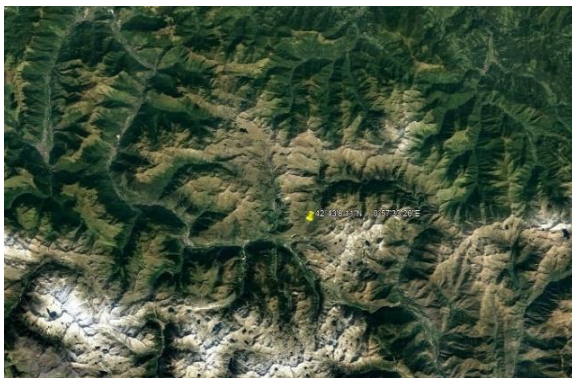
Photograph 11. Orography of the accident site

The geographical coordinates of the crash site, where the aircraft came to a halt, are 42° 43' 8.09" N - 0° 57' 33.14" E, elevation 1,851 m.

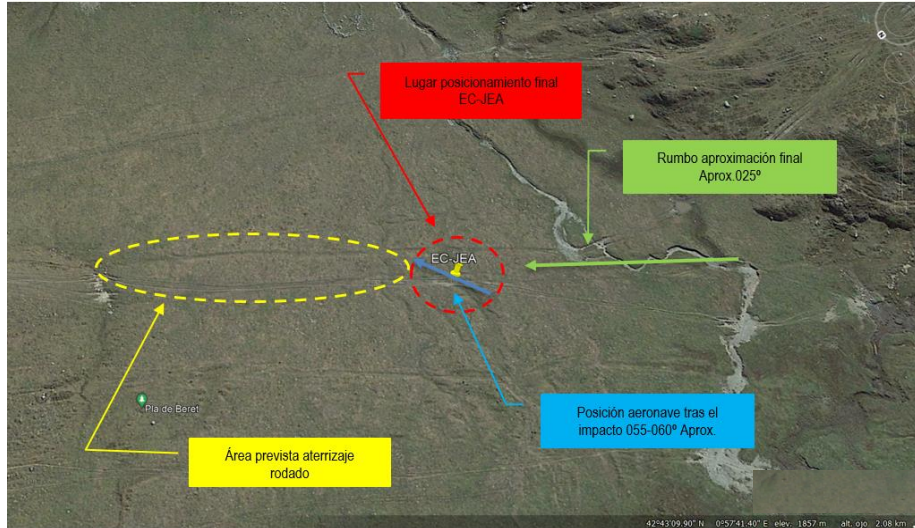
Figure 3. Sketch of the incident flight

It was indeed found that the system was experiencing intermittent failures, which meant that the event flight was not recorded, and there was no way of recovering the data.

was, however, recorded, and after assessing the cockpit's directional gyro after the impact and the testimonies provided by the crew, the operator produced an approximate sketch of the event flight, which is shown in Figure 3.
