CIAIM REPORT-10/2020

Fires in the engine room of the passenger and wheeled vehicle ferries
VOLCAN DE TENO, on May 16th 2019, and CHAMPION JET, on June 25th
2019.

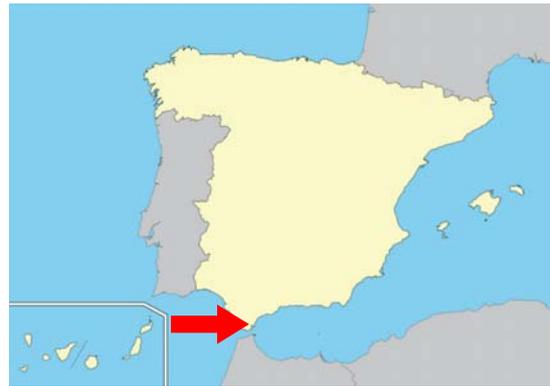
Figure 2. Accident site

On the 17th of May, after ventilating the space and carrying out the appropriate checks, the starboard engine room could be accessed. During the first inspection, it was found that the fuel feed tube (a hollow bolt, or *banjo bolt*) of fuel pump 1B of the SOME had snapped off. At the same time, two of the studs holding the fuel pump to the engine block had snapped and a third had no nut.

There were no personal injuries, contamination nor damage other than to the vessel. The fire only affected the starboard engine room. Apart from the damage to the studs and the fuel line, the fire affected the following elements, components or systems:

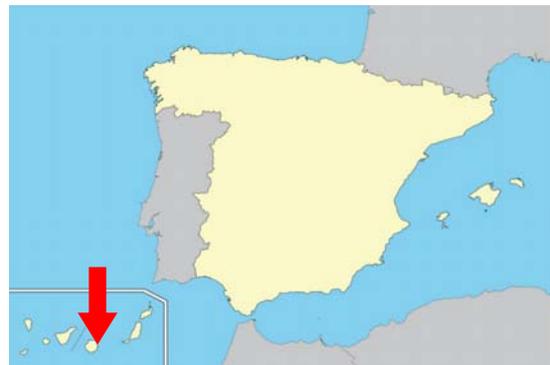
Figure 4.

The next day, after accessing the engine room affected, it was found that the fuel feed tube (a hollow bolt, or *banjo bolt*) of the fuel pump of cylinder A10 of the SOME had snapped off. The four studs attaching the fuel pump were also found to have snapped.

- The electrical wiring of the engine.
- Fire detectors above the SOME.
- Thermal insulation on the exhaust of cylinder A10.
- A hole, with dimensions of 420x300mm, was found in the bilge, in a structural stringer.
- Several reinforcement beams between ribs 14.5 and 15 were bent.

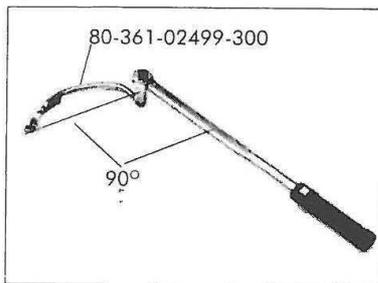
There have been a number of instances of fuel pump securing studs failing because these studs were not sufficiently tight. When this occurs there is a risk of fire from fuel leaking from damaged pipework.

It is recommended that the torque of all fuel pump studs is checked according to the following procedure.

Fuel pump tool 80-361-02499-300 should be fitted to a suitably calibrated torque wrench and positioned with the ring end perpendicular to the wrench shaft, see Fig 1. Care should be taken to ensure that the angle of 90° is maintained throughout the tightening operation and to avoid touching the push rod tube immediately to the right of the fuel pump. Failure to do so will result in under or over tightening. The torque should be checked by 'cracking' or reading the wrench indicator and a torque of 110Nm (85 lb. ft.) should be found. Any fuel pumps found with torque on any studs less than 90Nm (70 lb. ft.) should be removed and all studs, washers and nuts replaced with new components. Removed parts should be returned, clearly labelled with engine serial number, cylinder number and hours run, to the factory for inspection.
