Technical report IN-005/2022

Incident on 8 February 2022, involving a BOEING B767-332ER aircraft operated by Delta Air Lines, registration N1602, in UIR LECM (Galicia, Spain)

CIVIL AVIATION ACCIDENT AND INCIDENT INVESTIGATION COMMISSION

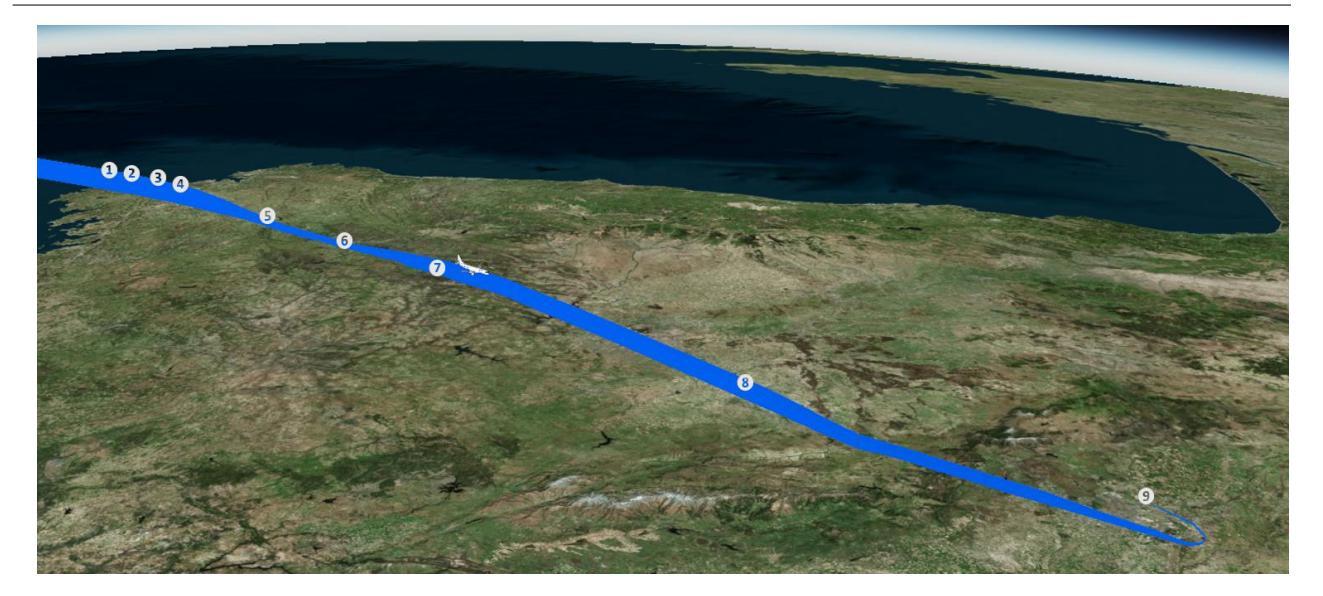
FIG. 1 FLIGHT PATH FROM ACTIVATION OF CABIN ALTITUDE WARNING TO LANDING.

(1)	06:24:44	FL370	Activation of CABIN ALTITUDE warning
(2)	06:25:31	FL370	ATC request to initiate descent
	06:26:11	FL370	Start of descent
(3)	06:28:35	FL340	Estimated position when the passenger oxygen masks were deployed
(4)	06:30:07	FL320	Emergency declaration
	06:31:07	FL300	Extension of speedbrakes
(5)	06:36:15	FL120	Aircraft at FL120
(6)	06:39:42	FL120	Start of climb to FL280
(7)	06:44:56	FL280	Aircraft at FL280
(8)	06:57:59	FL280	Start of descent from FL280
(9)	07:16:06	GND	Landing at LEMD

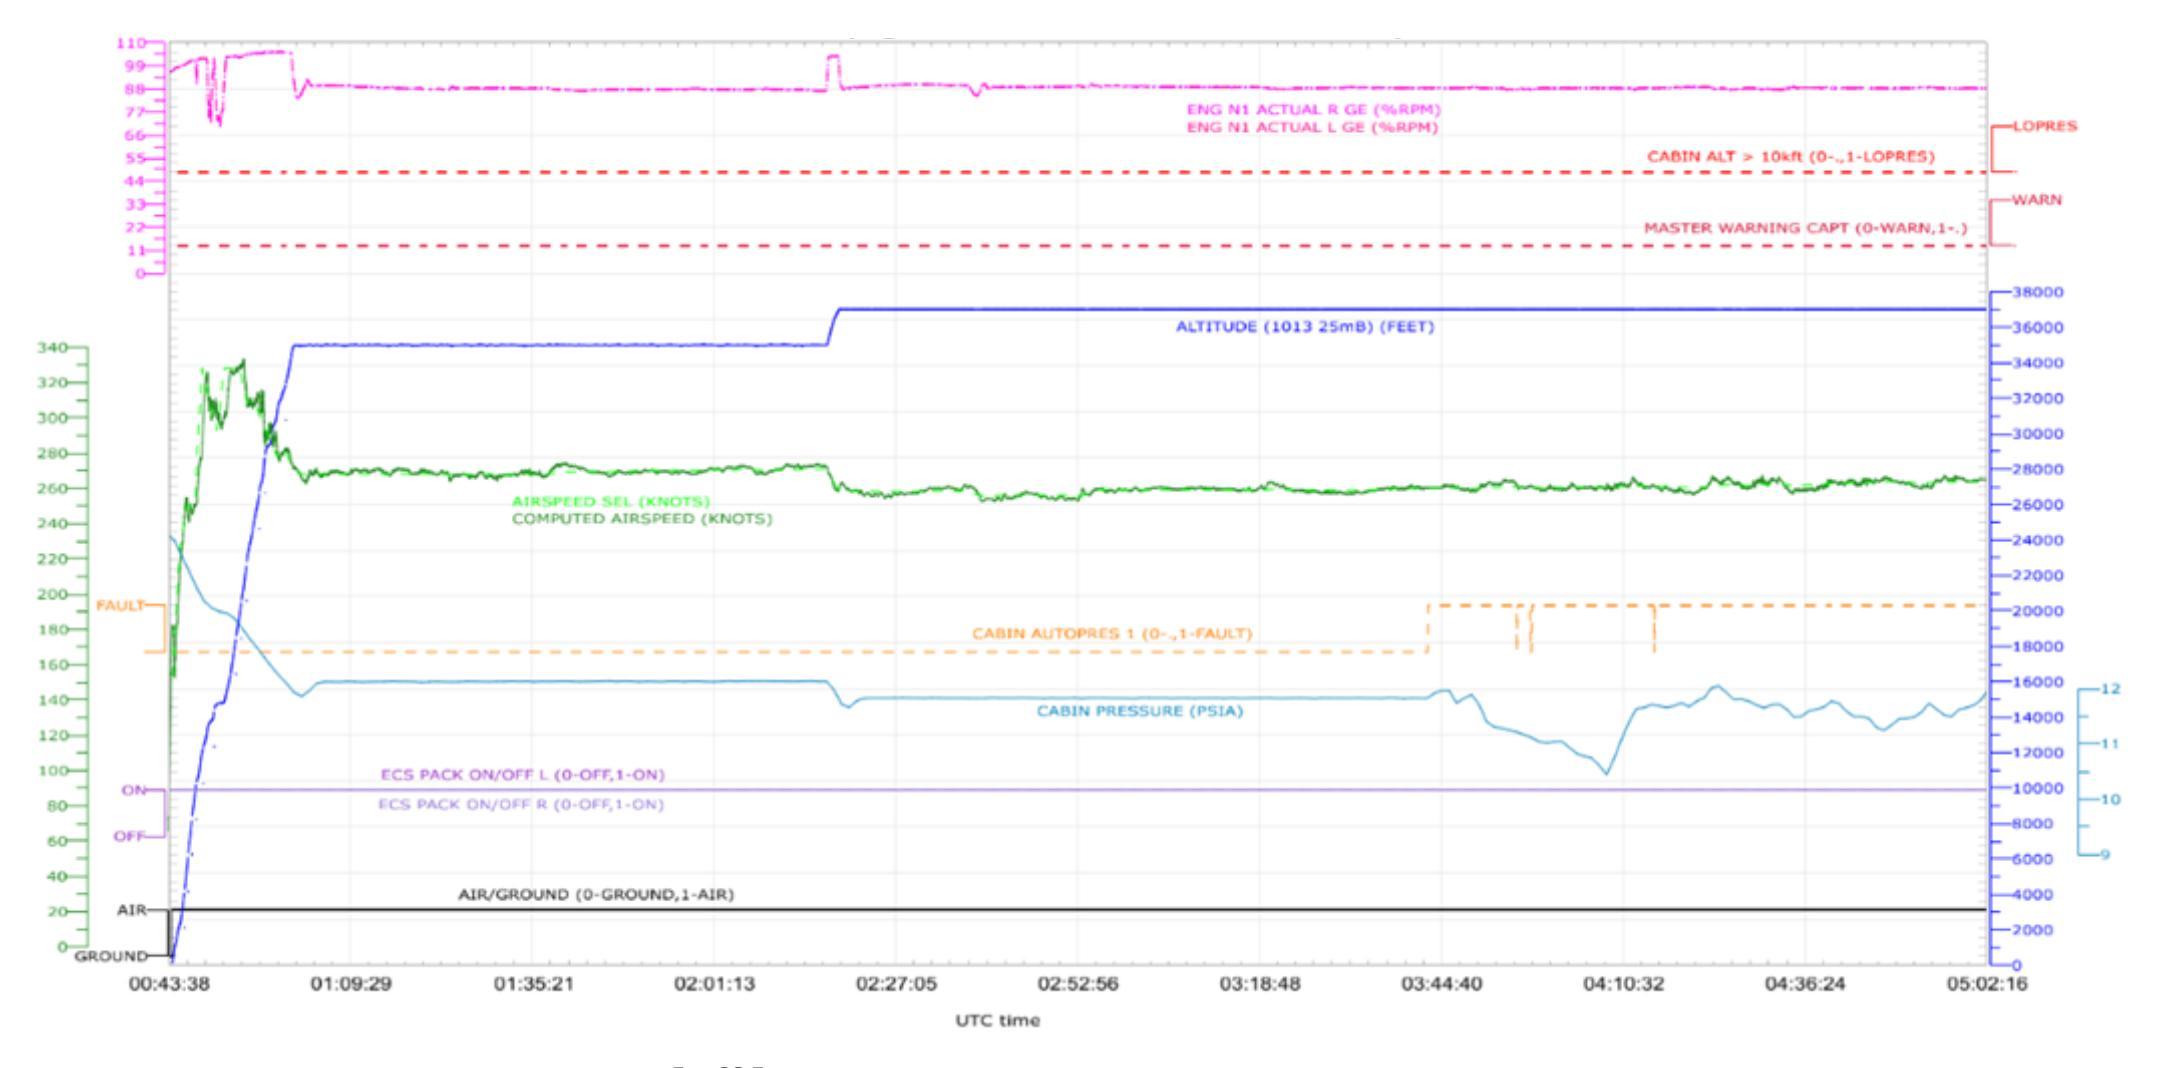
FIG. 23 FLIGHT PARAMETERS FROM TAKE-OFF UNTIL AFTER THE CABIN AUTO INOP WARNING.

The graphs in Figure 23 show that following the failure of the automatic pressure control on the incident flight, the cabin pressure dropped and rose, signalling the active manual control by the crew. Therefore, the OFV was responding to the movements commanded by the crew. From 06:17:04 h, the pressure started to decrease until it reached 10 psi at 06:24:44 h. Consequently, we can determine that this is the period in which the OFV was blocked, leading to depressurisation. It is believed that the water froze in the control arm or the OFV actuator linkage, preventing the motors from closing the OFV.
