Report

IN-020/2017

Incident involving an ATR 72-212A aircraft, registration EC-KKQ, operated by Swiftair, at flight level 170 in the vicinity of reporting point NARGO (Albacete-Spain) on 9 September 2017

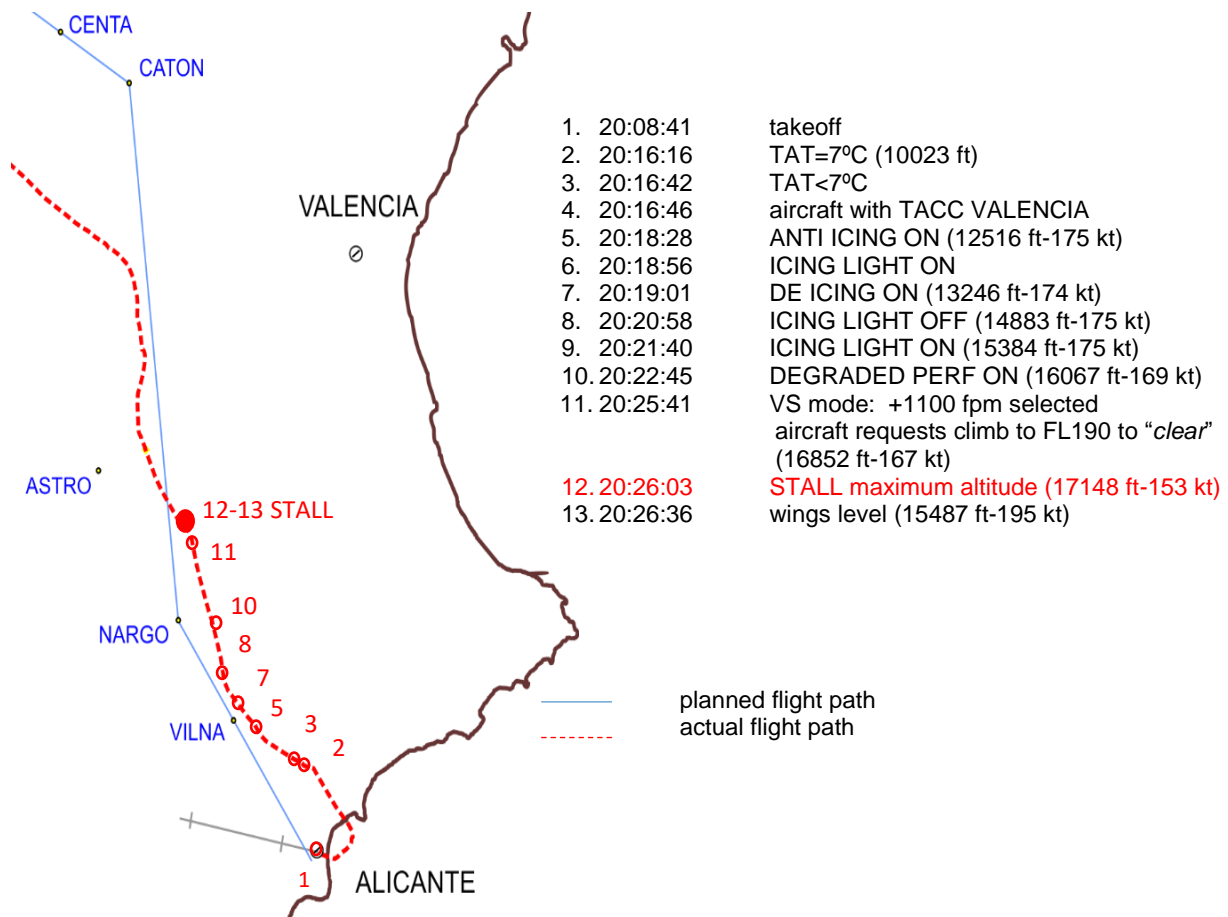
Figure 2. Flight path up to the event (18 min of flight time)

By 20:26:03, as a consequence of the previous actions, the aircraft had lost speed and was stalling at 153 kt. For 33 s, the aircraft descended, from 17148 ft to 15487 ft. During this descent, a minimum speed of 151 kt, an angle of attack of up to 19.6°, a pitch angle of up to -11°, and left and right bank angles of 58° and 39°, respectively, were recorded.

Stall was recovered at 20:26:36, 15487 ft and 195 kt.
