## **IN-040/2019**

Incident involving a Sikorsky S-76 C+ aircraft,  
registration EC-JES, over the Vigo estuary  
(Pontevedra) on 26 July 2019.

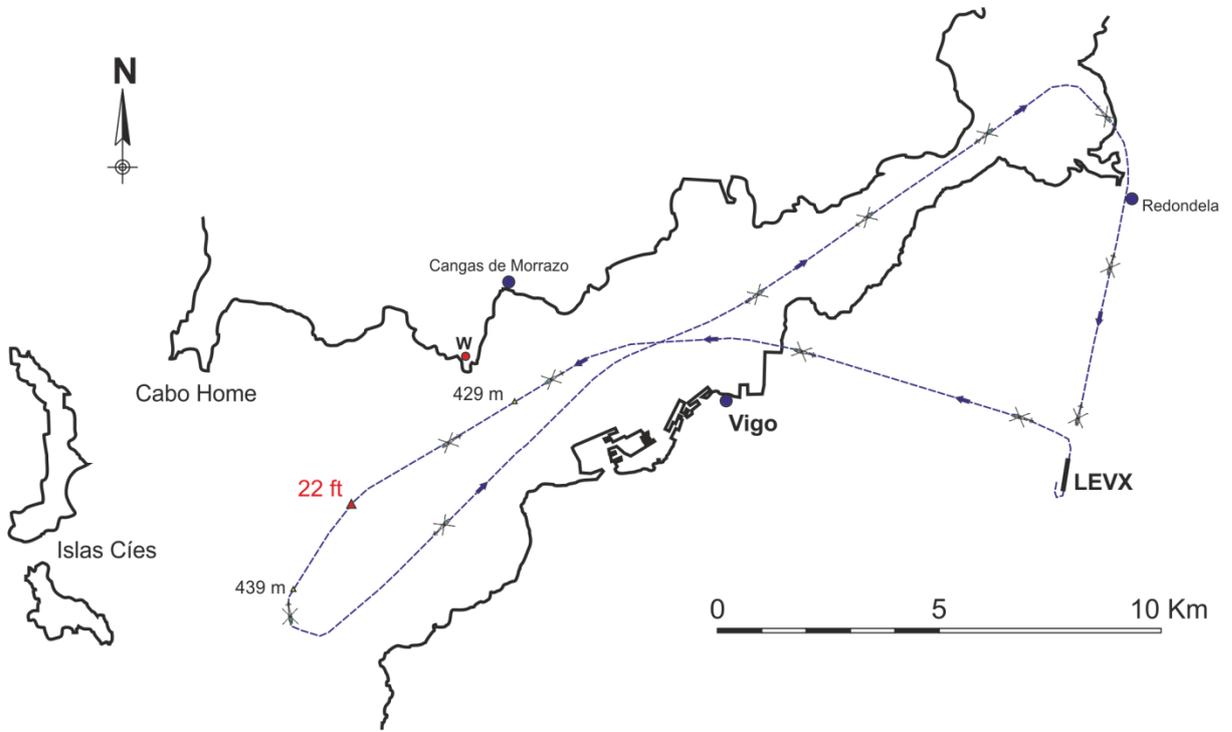
Fig. 1. - Aircraft flight path

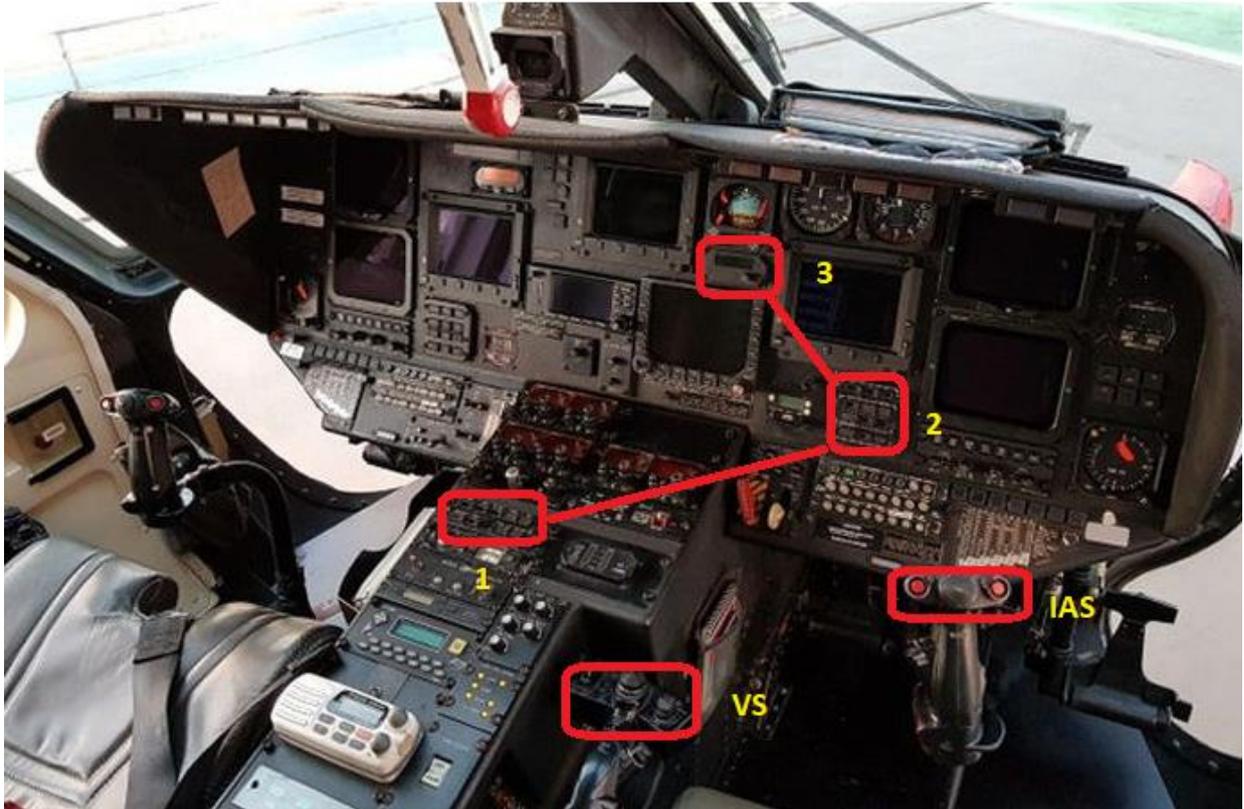
With regard to the use of the SPZ-7600 system controls, pilots initially select the ATT and FD1/2 modes on the PC-700 (1), then select several FD modes on the MS-700 (2). Before the descent, they select 500 ft of altitude on the AL-300 (3) to descend and maintain that height over the estuary, followed by the ALT PRE Mode on the MS-700 (2) and the desired descent rate of 800 ft followed by V/ S mode on the MS-700 (2). The VS figures and altitude are programmed into the AL-300 from the collective control lever.

Fig. 10. - Sequence of actions SPZ-7600
