Report

IN-052/2019

Incident involving an ATR 72-212 A aircraft, registration EC-MPI, operated by Canarias Airlines at the Tenerife North Airport (GCXO) on 15 October 2019

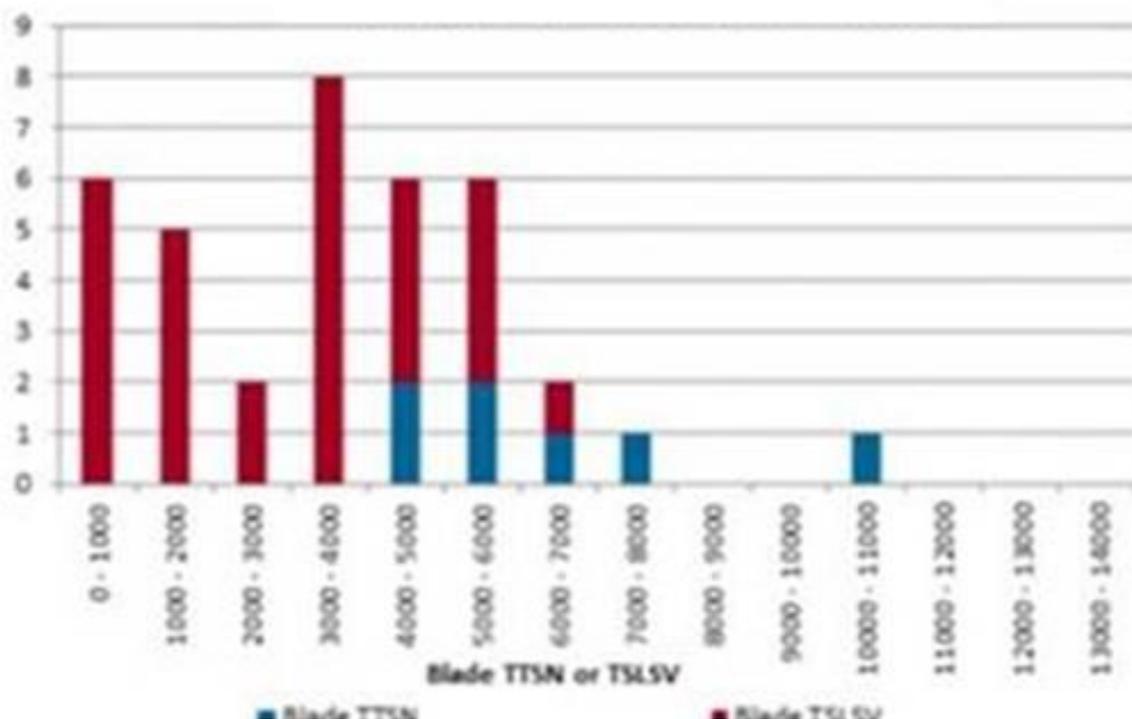
Figure 10. Events involving blades on PW100 engines between 2005 and 2015

In addition to the above cases, the graphs below show failure data for PT2 recorded by P&WC through the end of 2014 (37 incidents).
