Combined report on the investigations of
Two fatalities connected with the
operation of the workboat

GPS Battler

off Almeria, Spain

in Marin, Spain

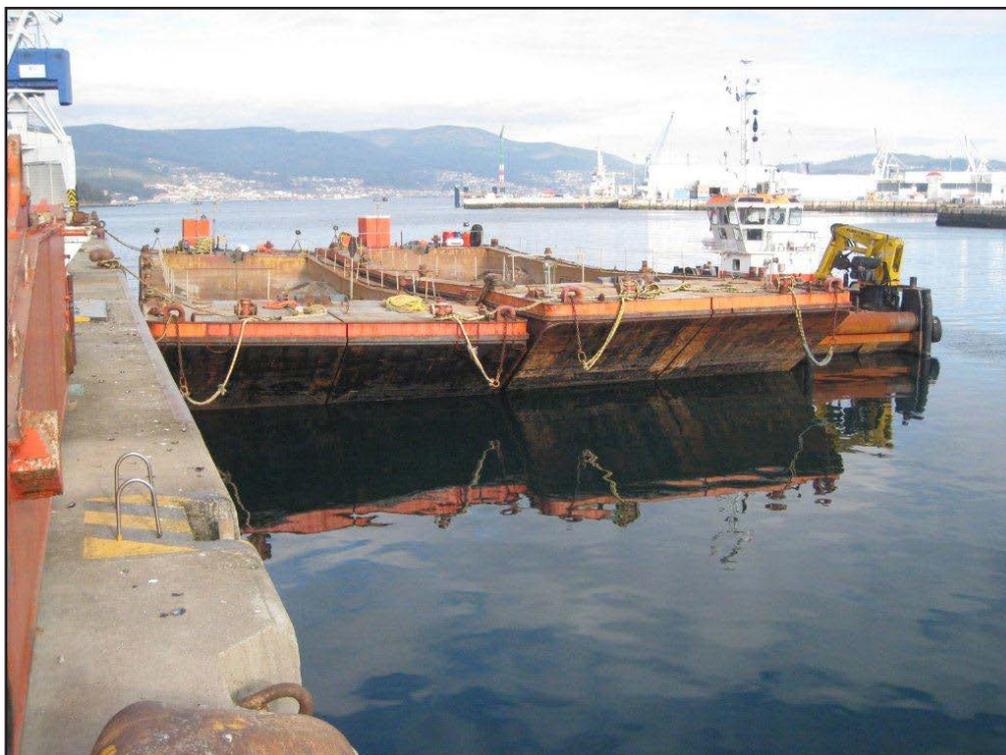
Figure 7: *GPS Battler* and barges moored alongside in Marin

At 2110⁹ on 5 January 2015, the mate arrived at berth No.0 on the New Commercial Pier in Marin, Spain to join *GPS Battler*, which was moored outboard of two split hopper barges (**Figure 7**). The workboat's master and bosun were also scheduled to re-join the vessel on the same evening.

GPS Battler had been moored outboard the two split hopper barges at No. 0 berth on the New Commercial Pier since 22 December 2014. The pier's concrete quay was unfenced, allowing open access to its edge (**Figures 7, 8 and 9**). The quay wall was fitted with a number of vertical ladders to provide access to vessels moored alongside.

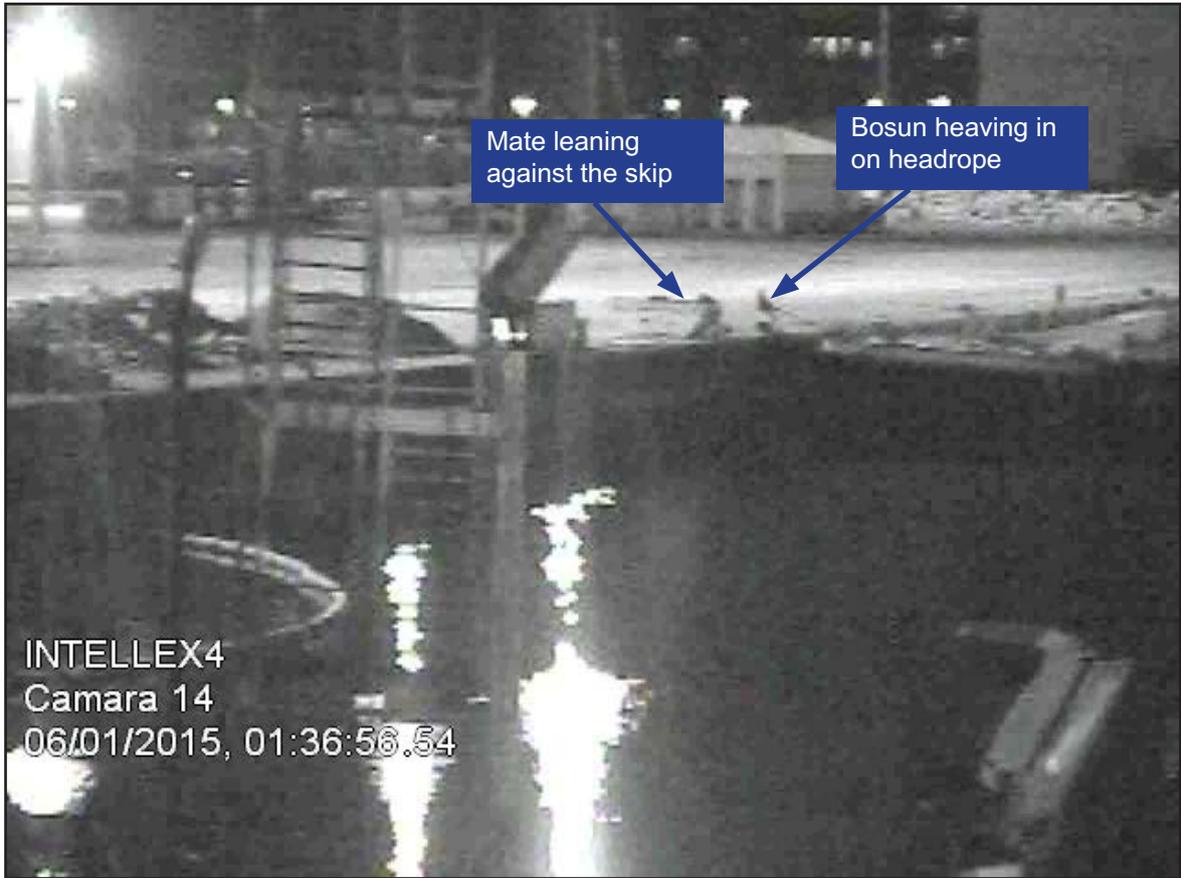
Figure 10: Still from CCTV at 0137 - bosun heaving in on headrope

The bosun left La Farola at 0120 and arrived by the workboat at 0135 to find the mate leaning against the side of the waste skip nearest to the barges. The bosun spoke to the mate but he did not respond, so the bosun told him to stay where he was. By now, the tide had risen and the deck of the inner barge was only a few centimetres below the level of the quay, so the bosun pulled on the inner barge's head rope (**Figure 10**) until the barge was close enough to the jetty to step on board.

Nobody saw the mate fall from the quay into the water. However, CCTV recordings show that he moved in front of the skip (**Figures 10 and 11**) at about the same time as the bosun entered *GPS Battler's* wheelhouse. It is almost certain that he fell from this area as he was below the skip when he was first seen in the water. It is considered that the mate was not moving to step across onto the barge when he fell as he had not moved his bag.

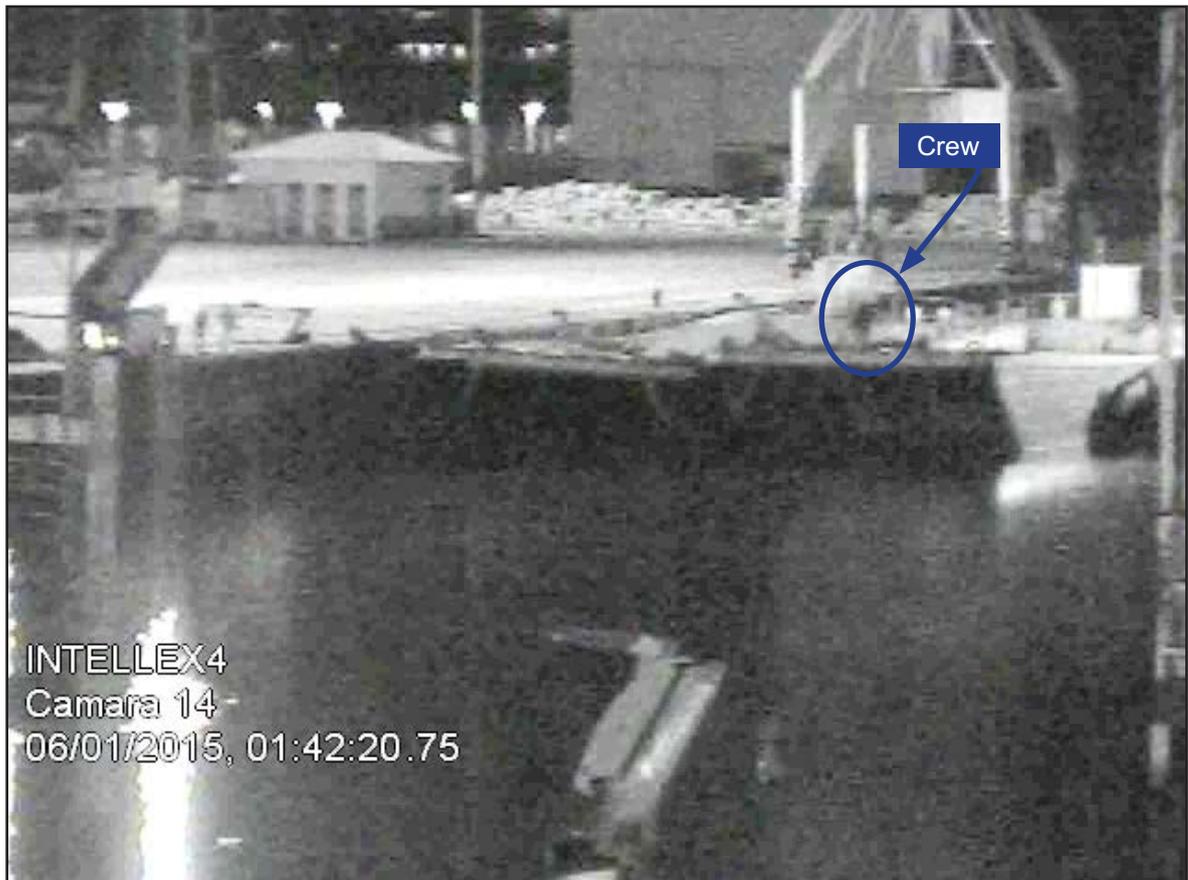
Figure 12: Still from CCTV at 0142 - crew searching for the mate

The bosun left the wheelhouse and alerted the engineers inside the accommodation. By 0142, the bosun and the engineers had started searching the water for signs of the mate (**Figure 12**). A short while later the mate was sighted a few metres ahead of the inner barge below the skip; he was floating face-down and was not moving. The bosun and the engineers tried to recover the mate from the
