MARINE SAFETY INVESTIGATION REPORT

Safety investigation into the serious occupational accident on board the
Maltese registered heavy lift /pipelay vessel

PIONEERING SPIRIT

MARINE SAFETY INVESTIGATION REPORT NO. 02/2021

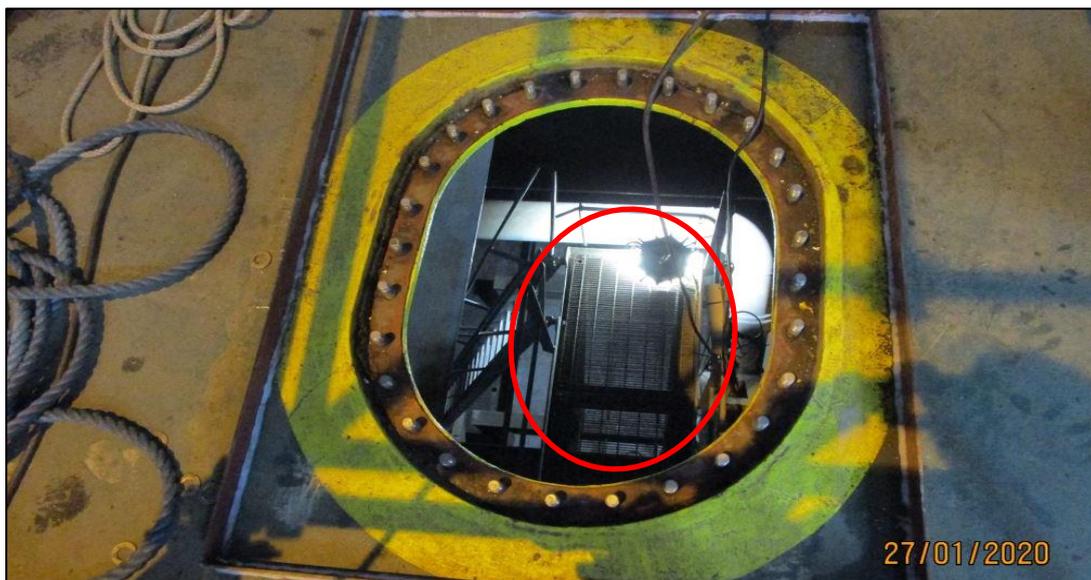
Figure 8: Access to WBT no. 1006 - First level platform with lighting installed marked

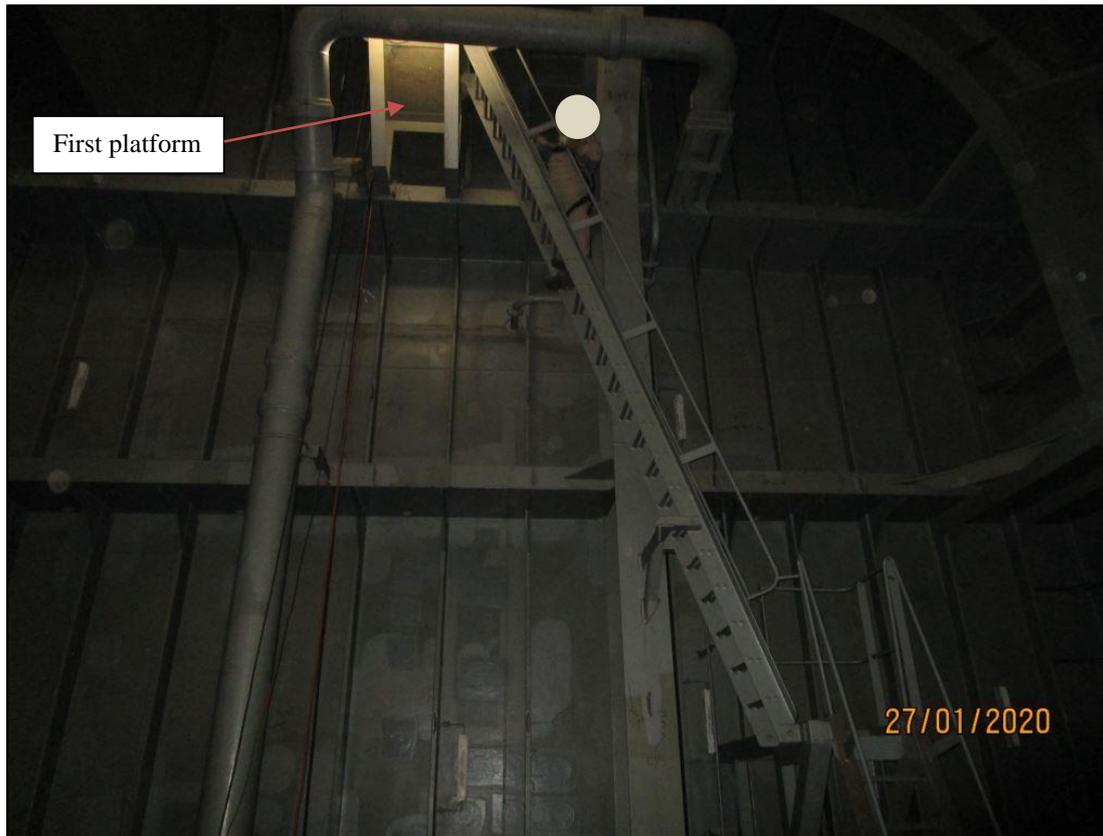
Inside the WBT, from the manhole, a vertical ladder led to the first platform, thence an access ladder with relatively steep steps led to the tween deck (Figure 9). The access ladder passed the trunk with approximately one metre of space in between (Figure 10), just before the ladder reached the tween deck. From the bottom of the stairs there was approximately five metres of passageway to an opening in the deck that led to the lower level of the tank (Figure 11), with another access ladder that led all the way to the bottom which was approximately 16 meters below. The five metres of passageway were bounded by a waist high guard rail.

Figure 9: Access ladder inside water WBT no. 1006

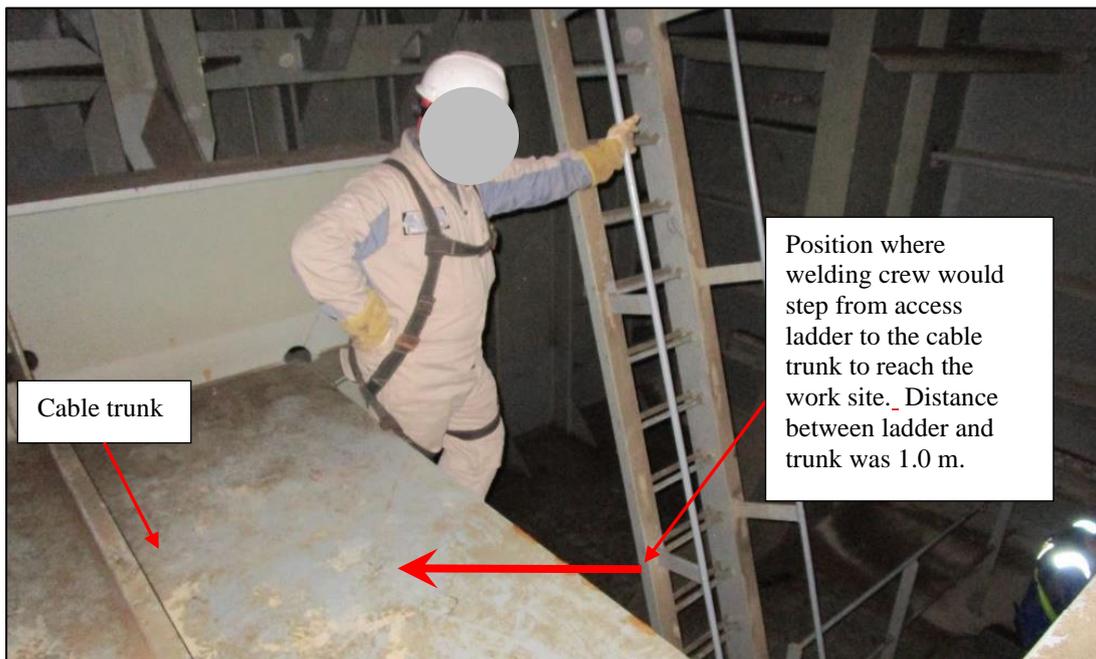
Figure 10: Access ladder passing cable trunk

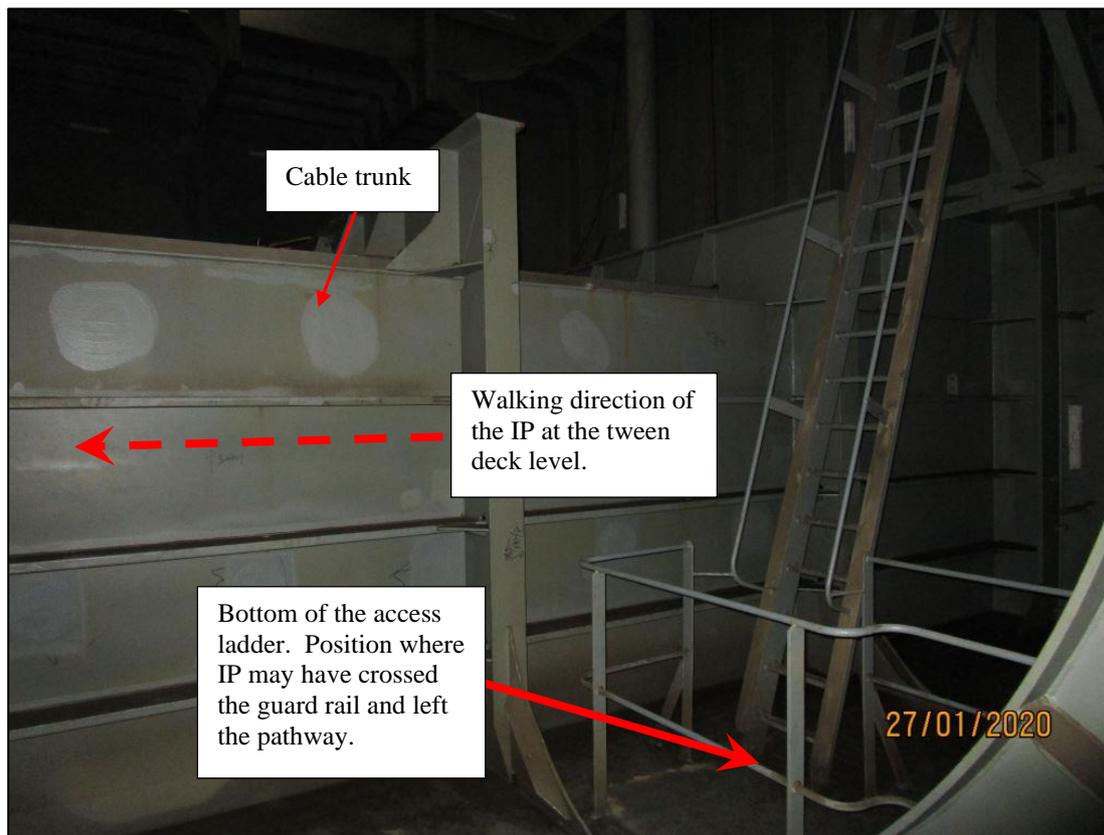
Figure 11: Access ladder ending at the tween deck

The IP deviated from the guided access inside the tank by crossing a guardrail which served as a barrier in between the access ladders and pathway, and the rest of the tank (Figure 11).. The IP fell through the opening in the deck on his way to the work site, landing on the bottom of the tank, a drop of about 16 m (Figure 15). The final location of the IP was slightly offset from the deck opening above, in an aft ward direction. This suggested that the IP was in motion and in the direction of the work site, when he fell through.
