## CIAIM REPORT 21/2018

### Collision between the ships FANTASTIC and VIKING STAR at the Port of Barcelona on 12 January 2018

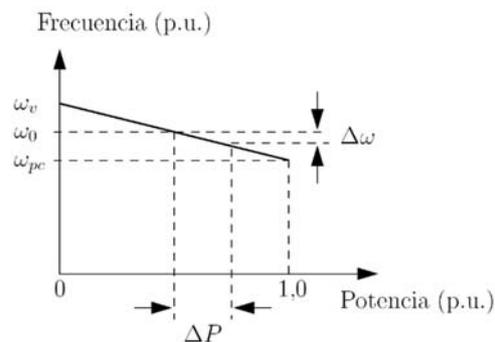
**Figure 11. Graph showing droop control in a generator**

When several synchronous generators are operating in parallel, load is shared between them by applying droop control to the mechanical governors of the primary motors. Droop control is a characteristic of the governor that allows the frequency of the motor to change slightly when the power demand changes. It is normal for generators to operate with a negative droop control of 3% to 5%, meaning that the motor RPMs at full load would be 3% to 5% lower than the no-load RPMs.

Generators have to work with negative droop control for the power plant to remain stable. Load sharing is a function of the droop of the generators.

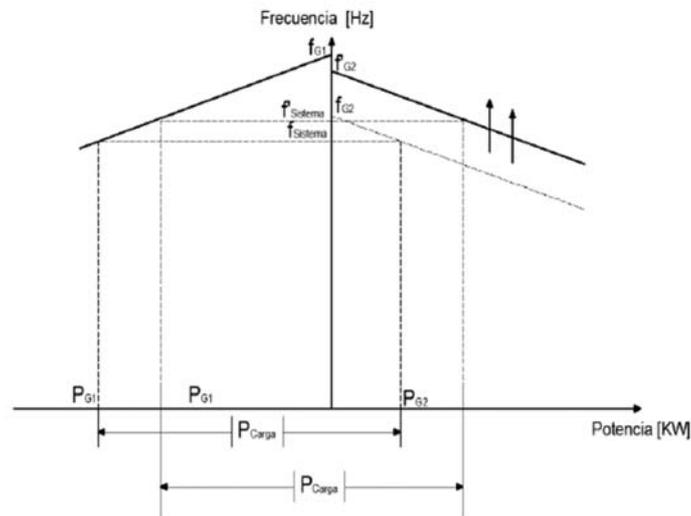
Figure 12. Load sharing between two synchronous generators in parallel

The load sharing between generators is modified by adjusting their speed. In the following figure, the electrical load  $P_{load}$  is shared between two generators, G1 and G2, as determined by their respective droop control (represented with the angled straight lines), to yield a stable system frequency,  $f_{system}$ . If the speed of G2 is now increased (equivalent to shifting the line representing its droop vertically), the load sharing is changed, with part of the load being transferred from G1 to G2. The system reaches a new equilibrium frequency,  $f'_{system}$ , that is different from the initial one.

That is, in an electric plant consisting of several synchronous generators operating in parallel, the controlling action of the primary regulation (by way of mechanical governors, the Woodward governor in this case) can be used to regain the balance between the provided and demanded powers, but with a shift in the frequency with respect to the reference frequency.
