# **Panama Maritime Authority**

**M/V "CAPE MED" R-071-2014-DIAM**

# REPORT ON THE INVESTIGATION OF THE COLLISION OF

At Algeciras, Spain On the 30<sup>th</sup> May 2014

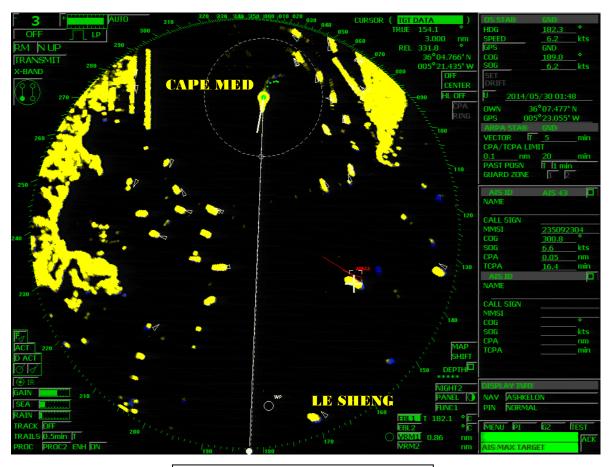
Figure 5.4 – LE SHENG on the radar at 03.48 hrs

- 5.17 At that time the LE SHENG was forward port of the CAPE MED but well clear heading north east towards Algeciras, Spain.
- 5.18 While heading south the CAPE MED maneuvered to avoid collision with a number of small boats.
- 5.19 Meantime the LE SHENG continued approaching the CAPE MED
- 5.20 While heading South the Master observed one green light and tried to find out to whom such light belonged to.

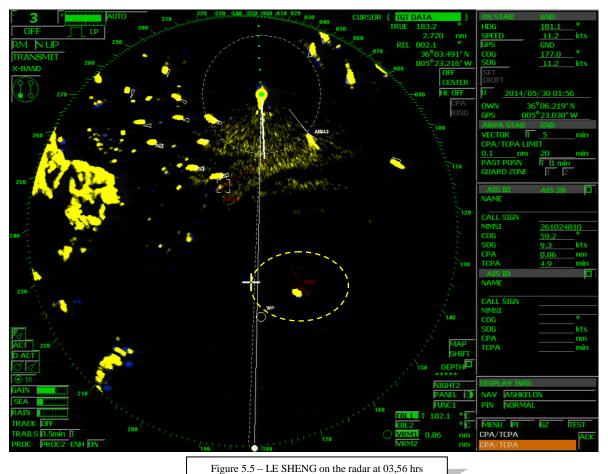
- Figure 3.5 LE SHENO on the fadai at 03,50 his
- 5.22 The LE SHENG continued approaching on the forward port quarter on a collision course at a speed of 9.3 knots.
- 5.23 Master tried to call the vessel targeted but no information was found on the AIS.
- 5.24 Master called immediately Gibraltar VTS requesting ship's name and asked VTS to call the other vessel to alter course since she was getting too close.
- 5.25 VTS confirmed the name of the vessel on VHF and Master tried to call.
