Report IN-003/2011

Incident involving an Airbus 330,
registration EC-LKE, operated by
Air Europa, at FL240 in the vicinity
of the Toledo VOR/DME (Spain),
on 13 February 2011

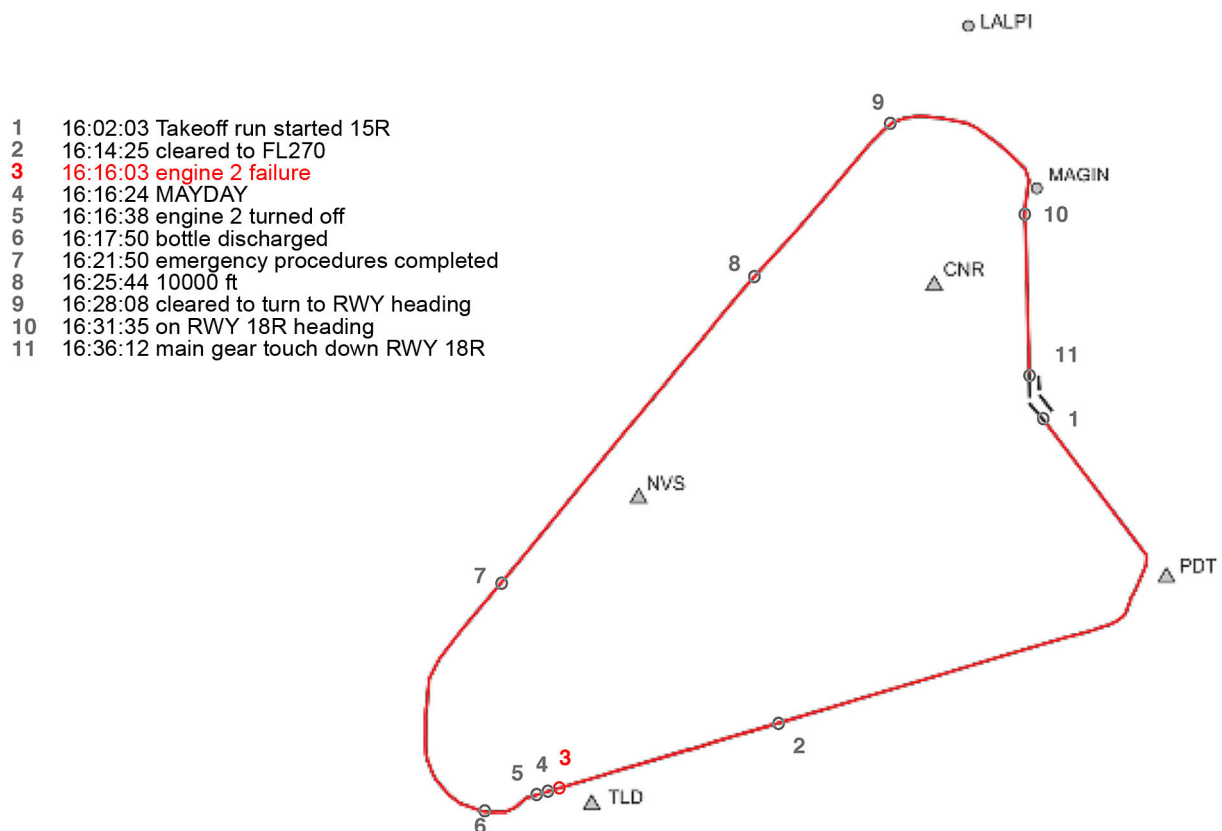
Figure 4. Flight path

In the cockpit, the failure (point 3 in Figures 4 and 5) caused a noise, a very strong vibration (which remained for the rest of the flight) and an aural warning (single chime). According to the FDR data the engine 2, N3 vibration increased from 0.5 to 2.6 CU. The captain called out the warning shown on the ECAM¹⁶, which was initially an ENGINE

Twenty-one seconds after the fault, the first officer, as instructed by the captain, declared a MAYDAY and, 35 seconds after the fault (point 5 in Figure 4), the crew turned off the right engine (ENGINE MASTER OFF), the last item in the ENGINE STALL procedure.

was discharged 21 seconds later, that is, 1 minute 47 seconds after the engine failure (point 6 in figures 4 and 5).

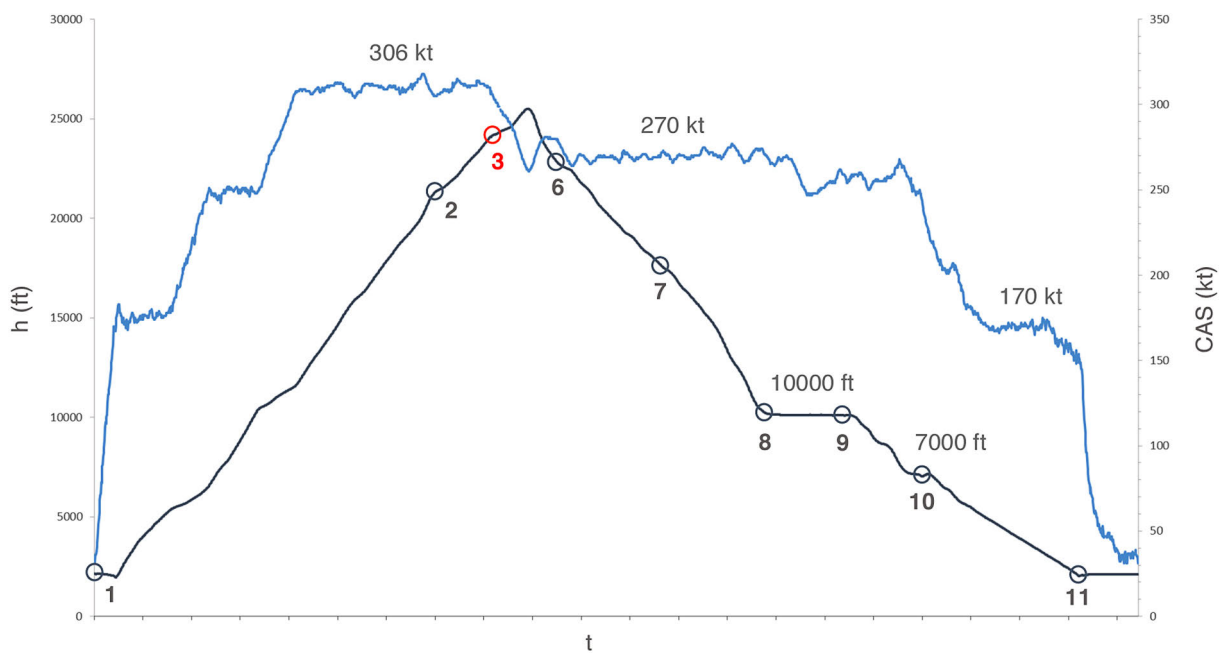
Figure 5. Altitude and speed (CAS) during the flight (points 1 to 11 refer to figure 4)

The After ENGINE SHUTDOWN procedure lasted 2 minutes 27 seconds. After it was completed they confirmed with the captain to "remove status", and the captain recalled out loud that they had to "look at the overweight" (landing with excess weight). This concluded the abnormal and emergency procedures after the engine failure, five minutes after the start of the emergency (point 7 in figures 4 and 5).

At 16:25 (point 8 in figures 4 and 5) the aircraft was still headed northeast toward LALPI and reaching 10,000 ft. The captain twice asked ATC for a fast descent, and again relayed their urgent need to return to the airport as fast as possible. Since they were at the minimum sector altitude (10,000 ft), they were unable to descend until 16:28 (point 9 in figures 4 and 5), when ATC cleared them to turn right to the runway 18R ILS and descend to 8,500 ft, thus shortening the maneuver. This clearance took the aircraft close to an Air Nostrum that was ahead of them on approach to 18R. To separate them, ATC instructed the Air Nostrum to divert to the 18L localizer and then to turn left. The Air Nostrum aircraft complied with ATC's instructions at all times.

At 16:31 (point 10 in figures 4 and 5) the aircraft intercepted the runway heading at a CAS of 220 kt. Throughout the descent they were very mindful of their speed and altitude due to their overweight. They deployed the airbrakes four times and two minutes later, at 16:33, slowed to 170 kt, a speed they held until the landing.
